**FINAL REPORT
ASBESTOS SAMPLING &
LEAD PAINT TESTING**

**DUNEDIN TERRACE
RESIDENTIAL UNITS 175-218**

**ST. PAUL PUBLIC HOUSING AGENCY
261 EAST UNIVERSITY AVENUE
ST. PAUL, MN 55101**

January 8, 2015

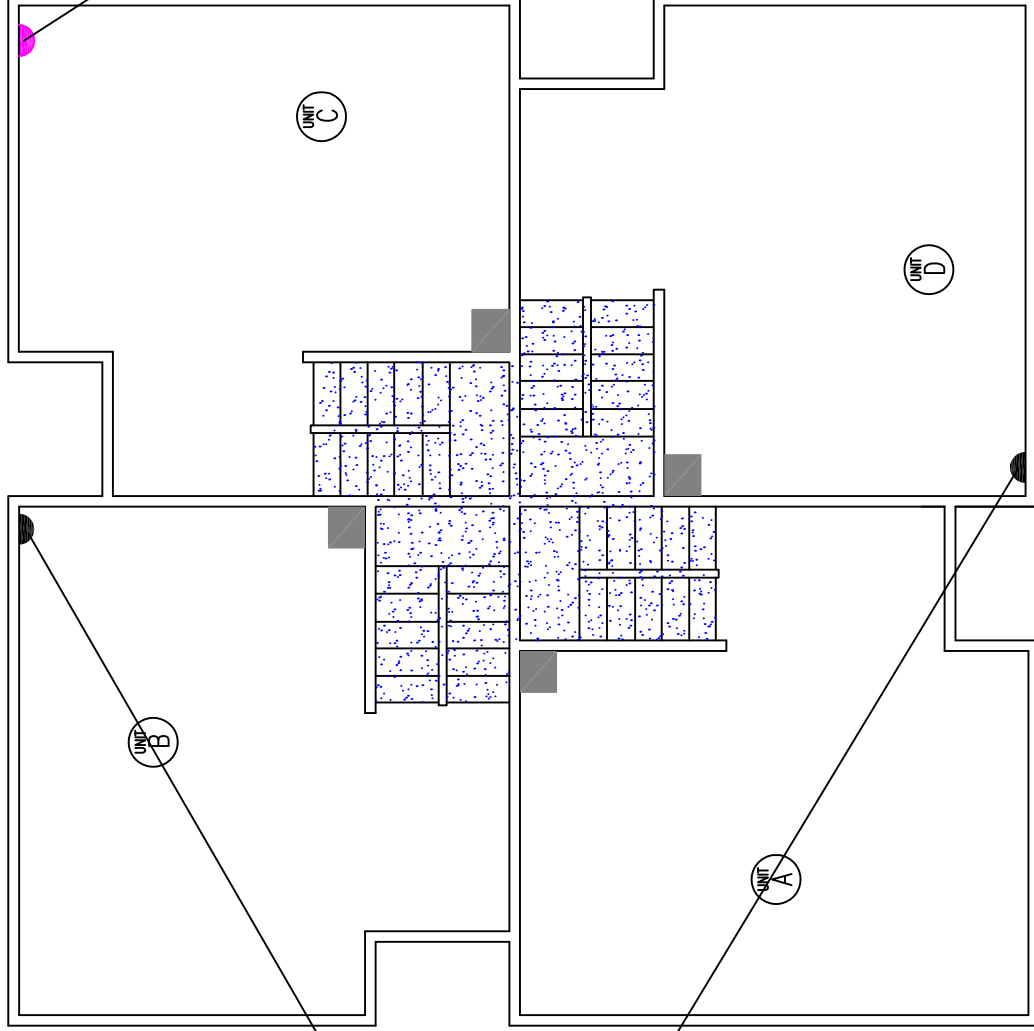
DIAGRAM 175-6
ASBESTOS TAPING COMPOUND LOCATIONS

ASBESTOS GAS PIPE
PENETRATION PUTTY

ELECTRICAL CONDUIT
PENETRATION PUTTY

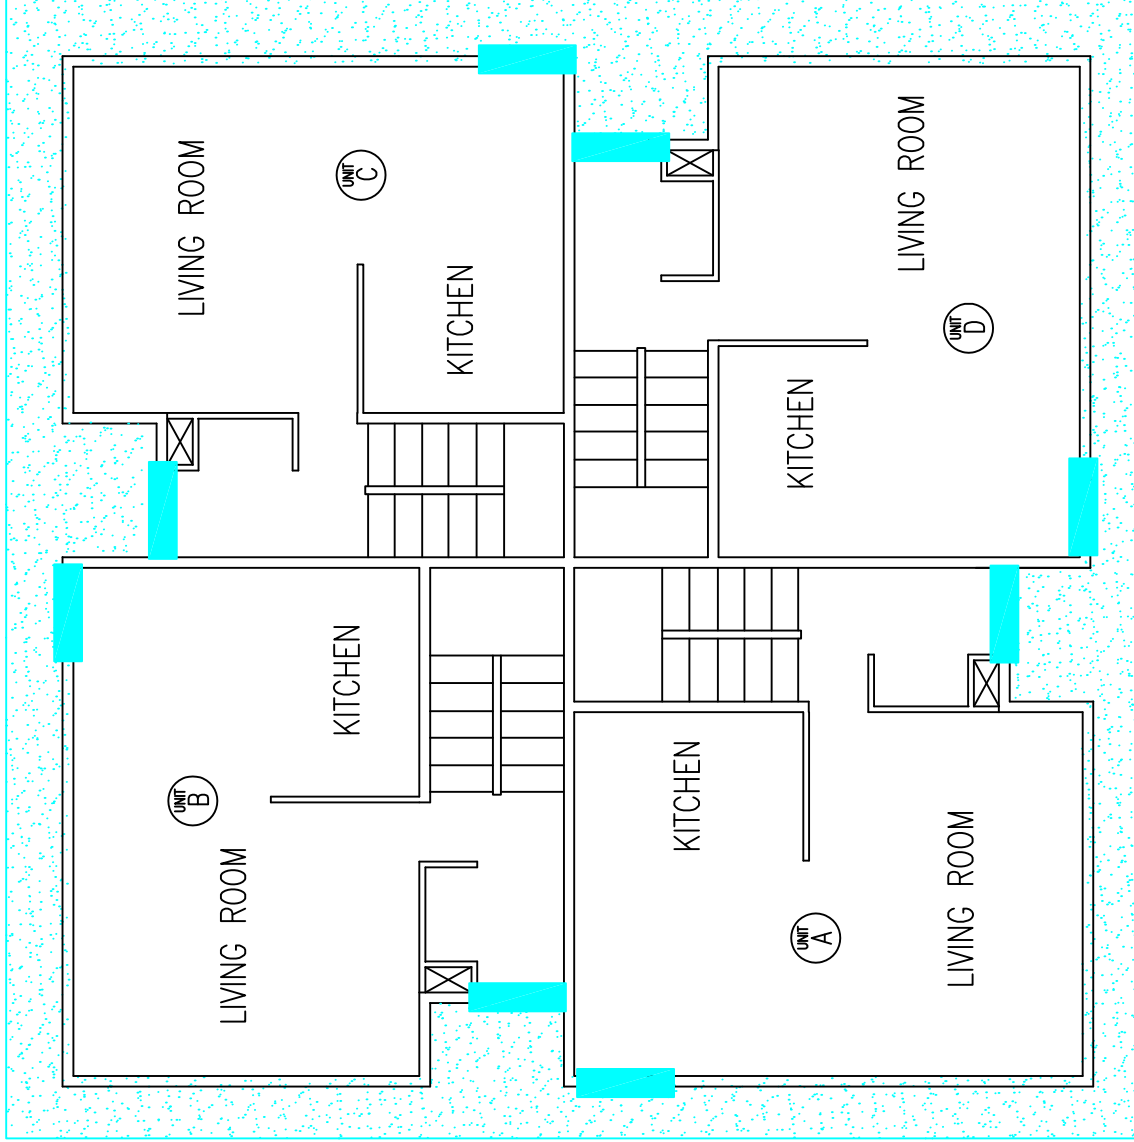
DIAGRAM 175-10 SAMPLING LOCATIONS

— LEAD-BASED PAINT ON EXTERIOR
DOOR JAMBS

— TAN/WHITE LEAD-BASED PAINT ON
LOWER SOFFIT

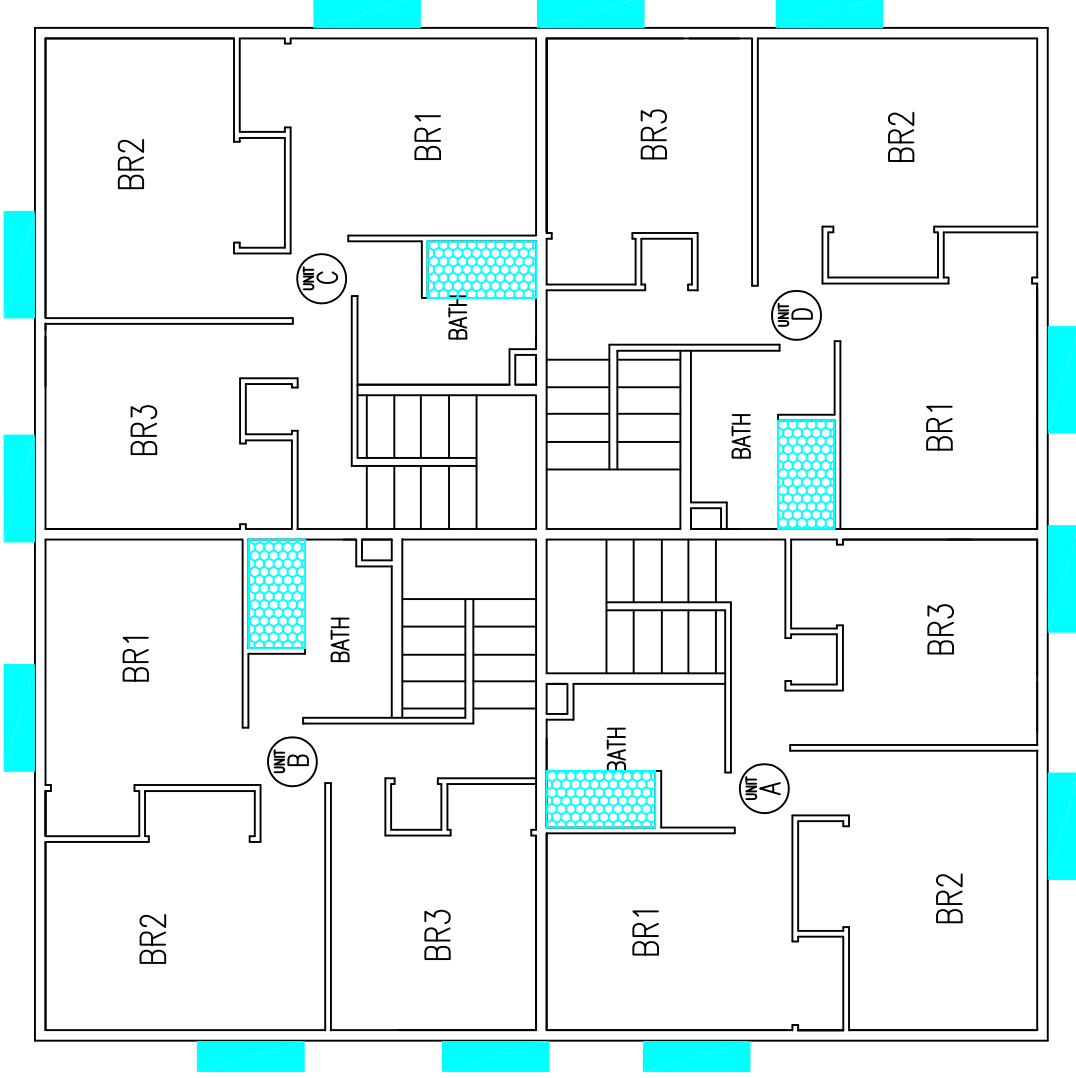
DIAGRAM 175-11
LEAD-BASED PAINT LOCATIONS

- LEAD-BASED PAINT ON EXTERIOR VERTICAL WINDOW CASING (2"X6" BOARDS)
- LEAD-BASED PAINT ON TUB

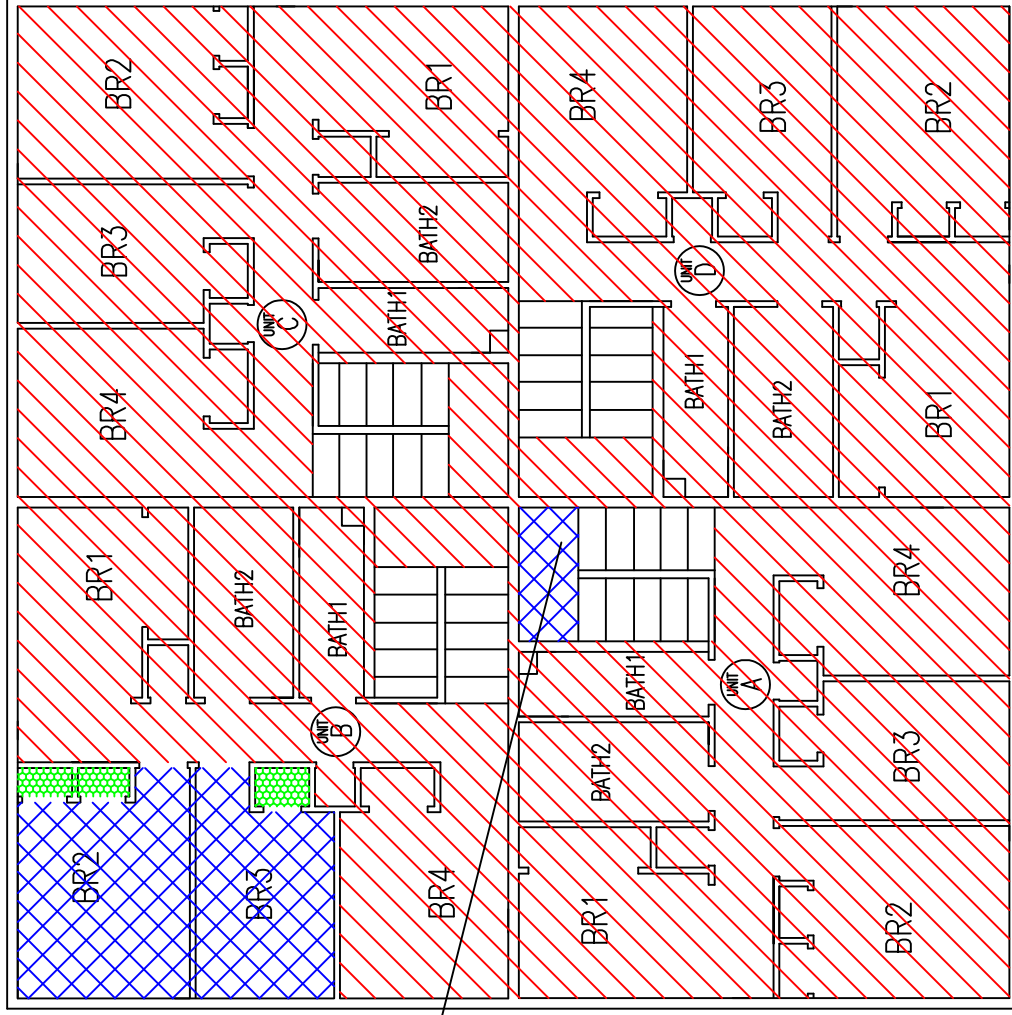
DIAGRAM 179-5 ASBESTOS FLOORING LOCATIONS

-ASBESTOS FLOOR TILE AND MASTIC UNDER NON-ASBESTOS SHEET FLOORING
	-ASBESTOS FLOOR TILE AND MASTIC
	-ASBESTOS FLOOR TILE MASTIC UNDER NON-ASBESTOS FLOOR TILES

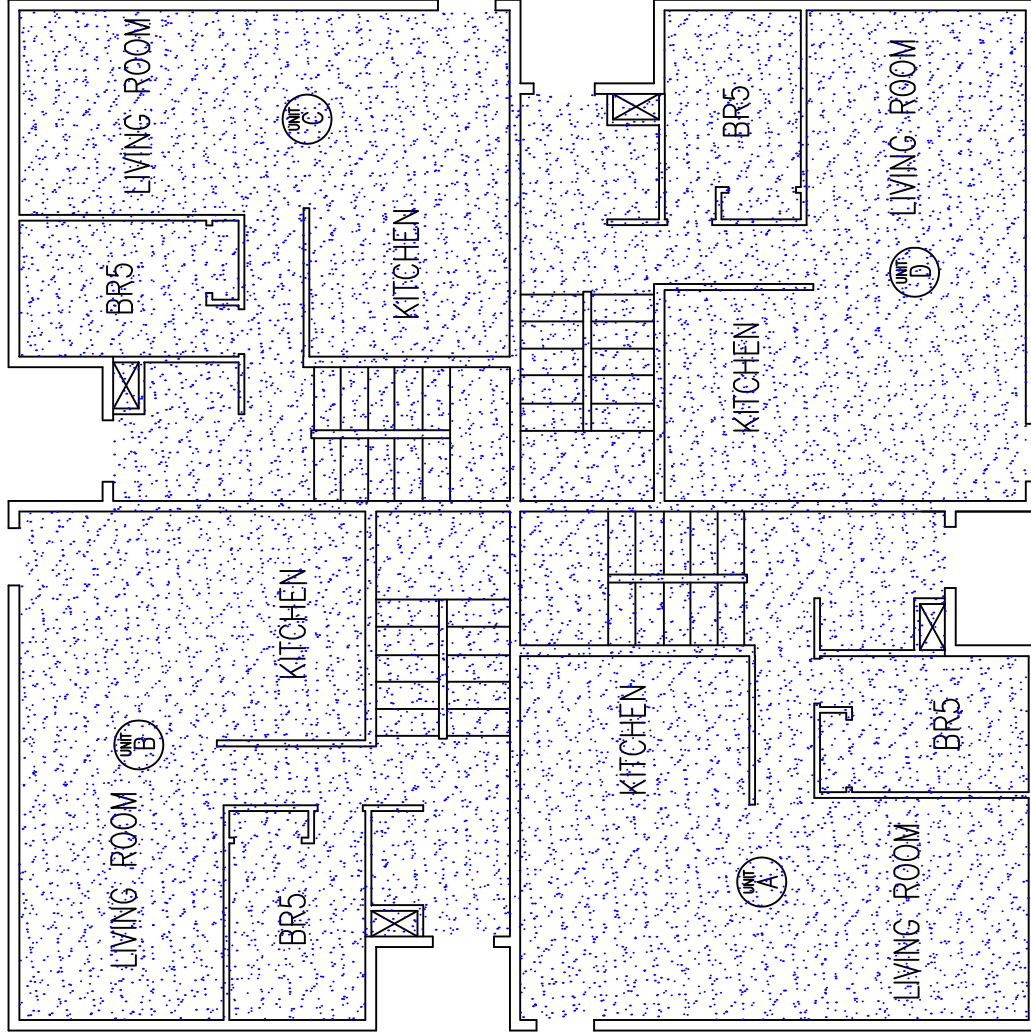
DIAGRAM 179-7
TAPING COMPOUND LOCATIONS

-ASBESTOS TAPING/JOINT COMPOUND

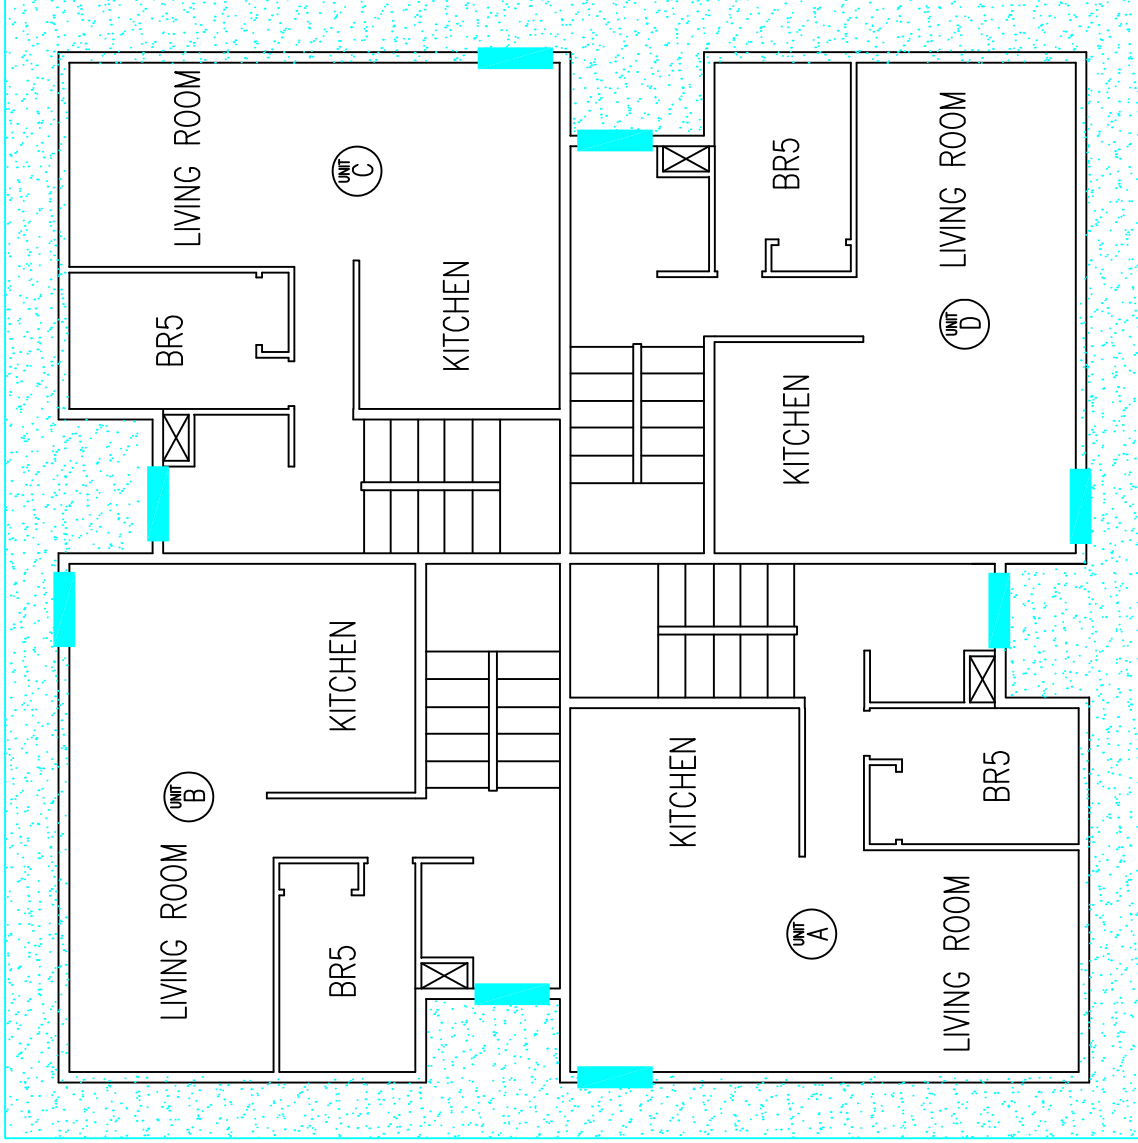
DIAGRAM 179-10
LEAD-BASED PAINT LOCATIONS

- LEAD-BASED PAINT ON EXTERIOR DOOR JAMBS
- TAN/WHITE LEAD-BASED PAINT ON LOWER SOFFIT

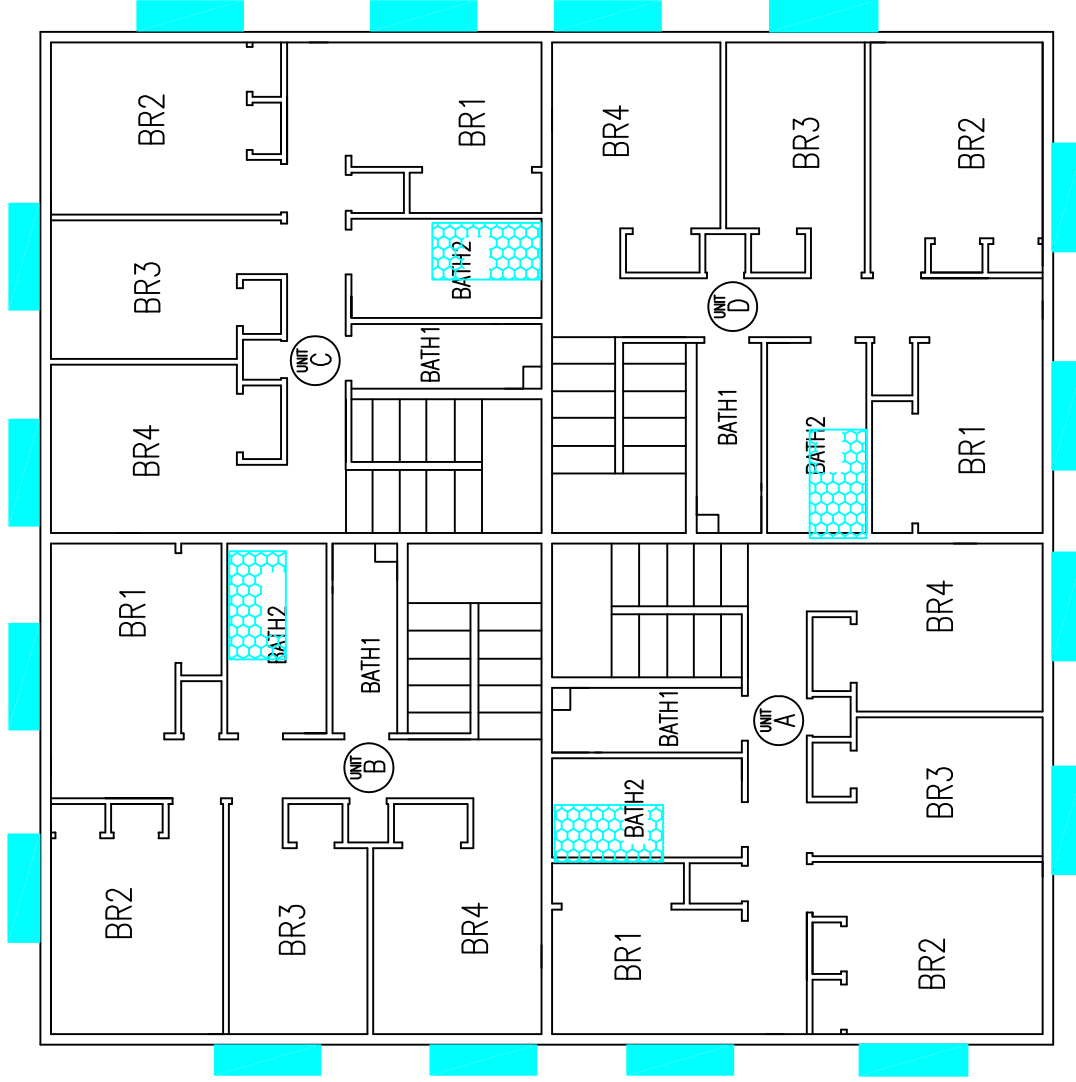
DIAGRAM 179-11

- LEAD-BASED PAINT ON EXTERIOR VERTICAL WINDOW CASING (2"X6" BOARDS)

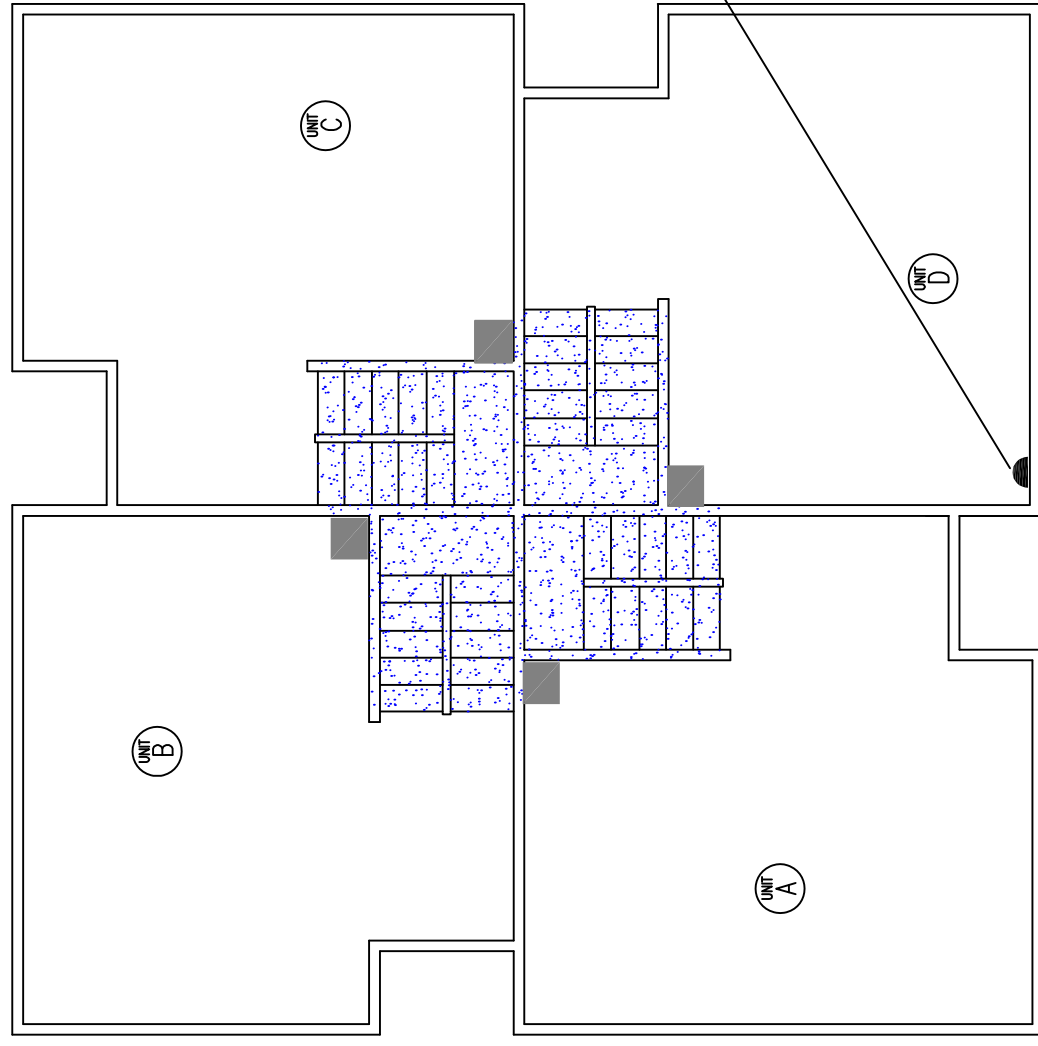
DIAGRAM 183-6
ASBESTOS TAPING COMPOUND LOCATIONS

ELECTRICAL CONDUIT
PENETRATION PUTTY

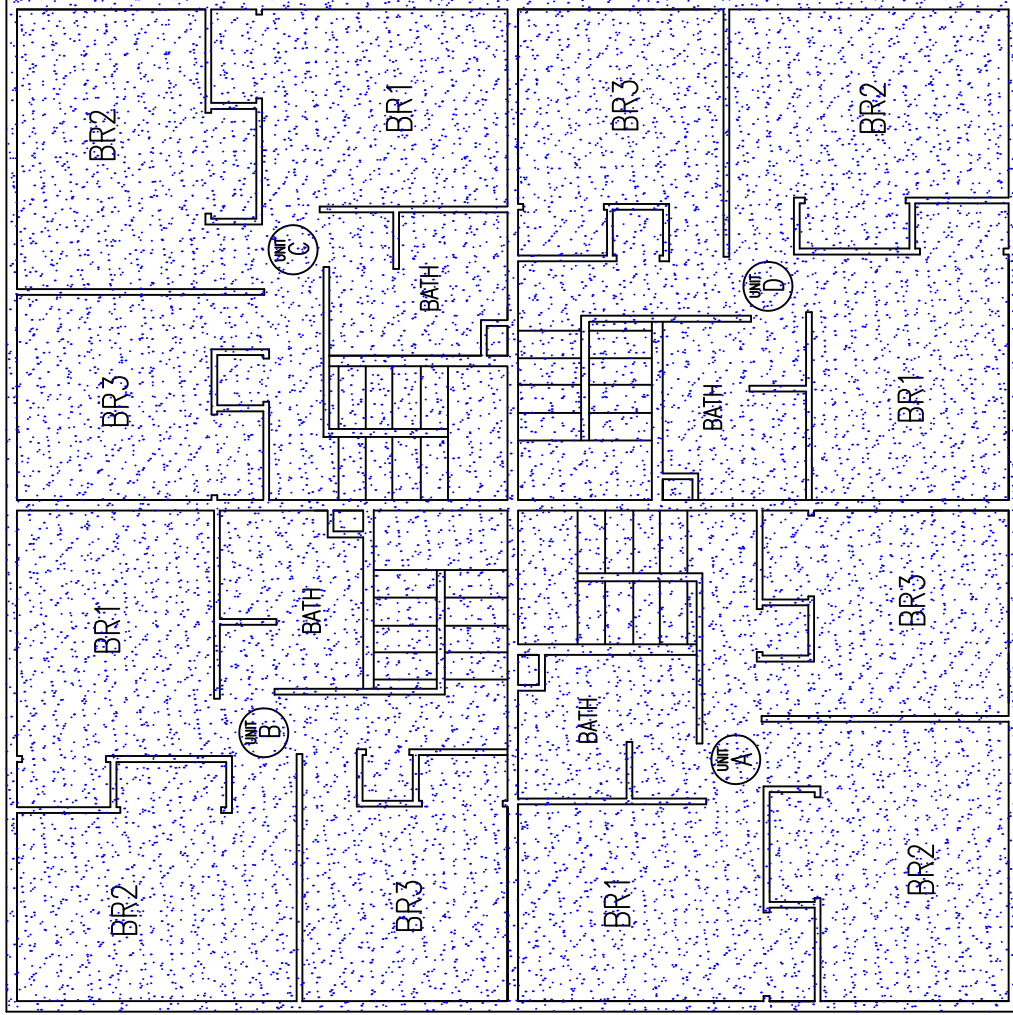
DIAGRAM 183-8
ASBESTOS TAPING COMPOUND LOCATIONS

-ASBESTOS TAPING/JOINT COMPOUND

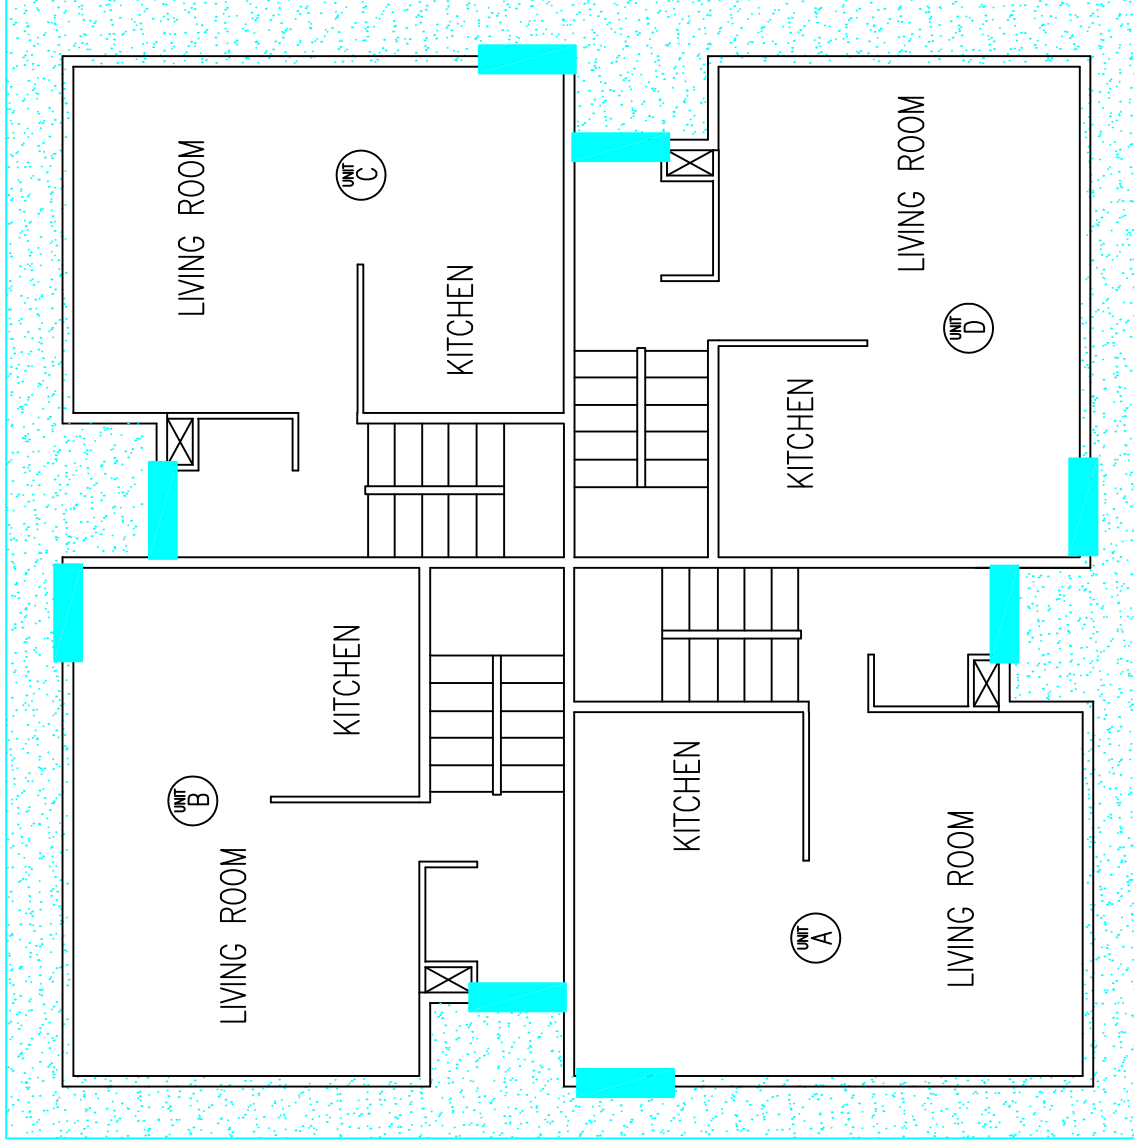
DIAGRAM 183-10 SAMPLING LOCATIONS

— LEAD-BASED PAINT ON EXTERIOR
DOOR JAMBS

— TAN/WHITE LEAD-BASED PAINT ON
LOWER SOFFIT

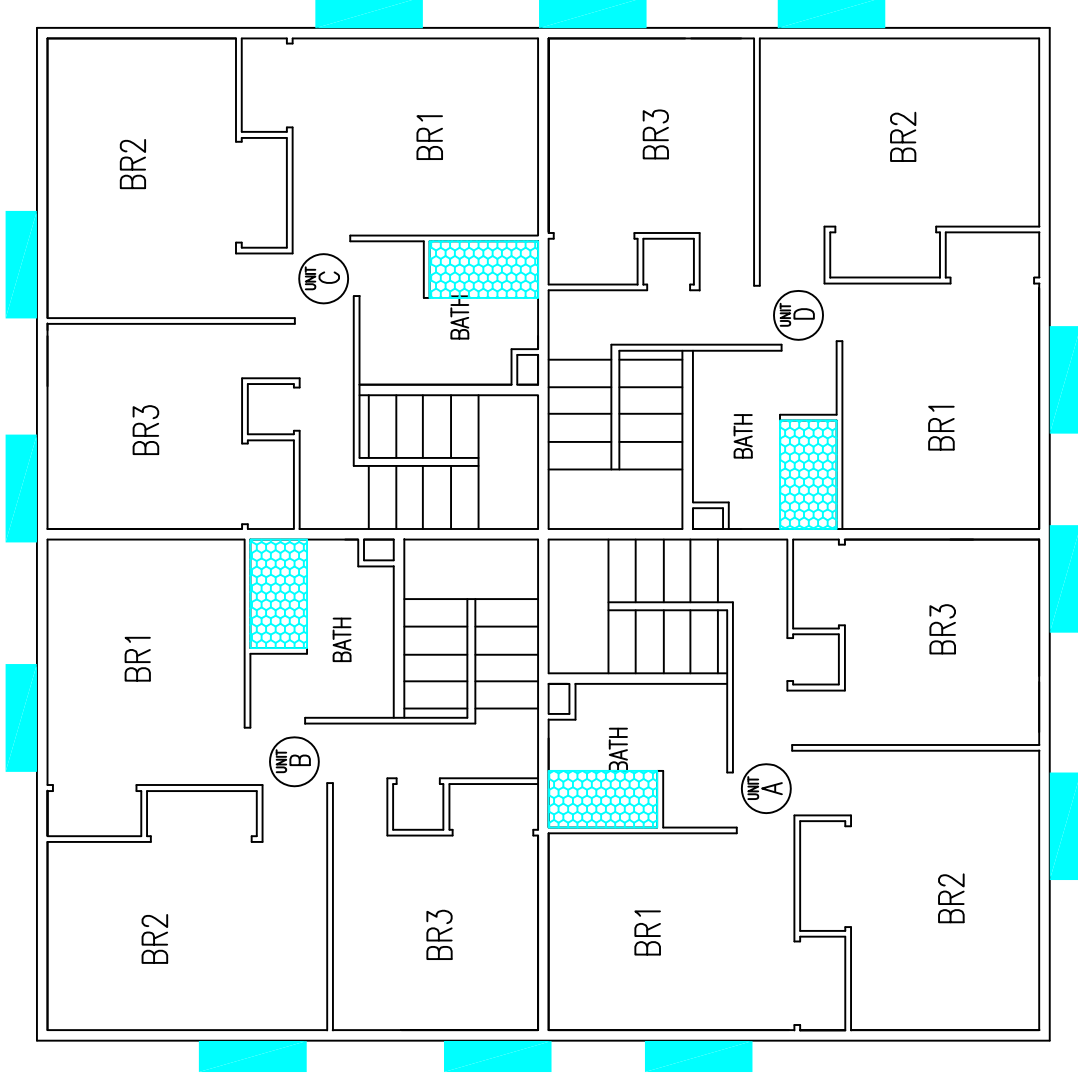
DIAGRAM 183-11
 LEAD-BASED PAINT LOCATIONS

— LEAD-BASED PAINT ON EXTERIOR
 VERTICAL WINDOW CASING (2"X6" BOARDS)
 — LEAD-BASED PAINT ON TUB

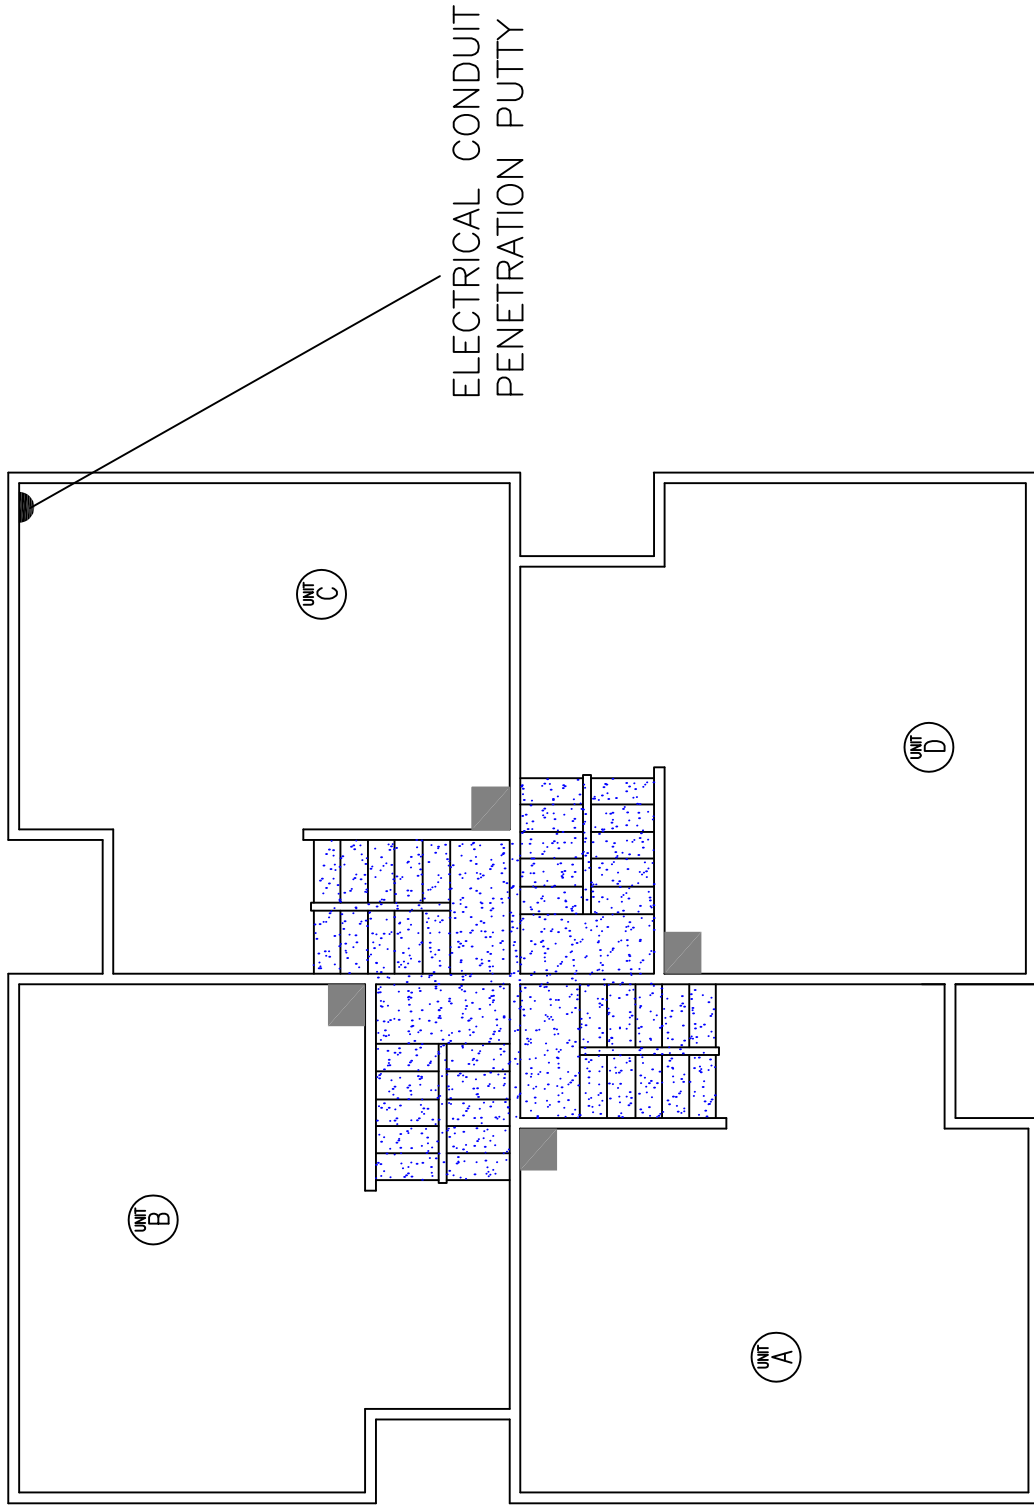
DIAGRAM 187-6
TAPING COMPOUND LOCATIONS

- ASBESTOS FLUE PACKING/MORTAR AT LOWER (OLD) HOLE
- ASBESTOS TAPING/JOINT COMPOUND

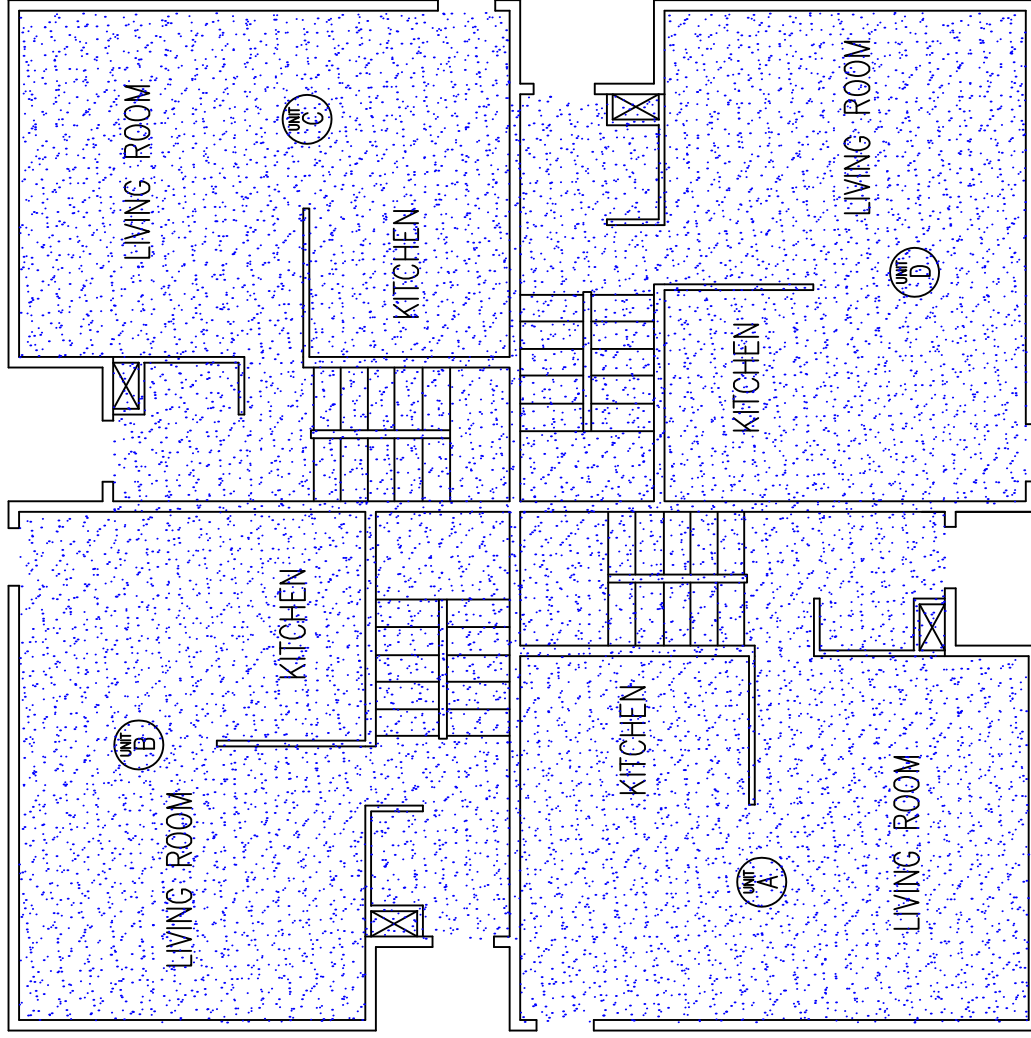
DIAGRAM 187-7
TAPING COMPOUND LOCATIONS

-ASBESTOS TAPING/JOINT COMPOUND

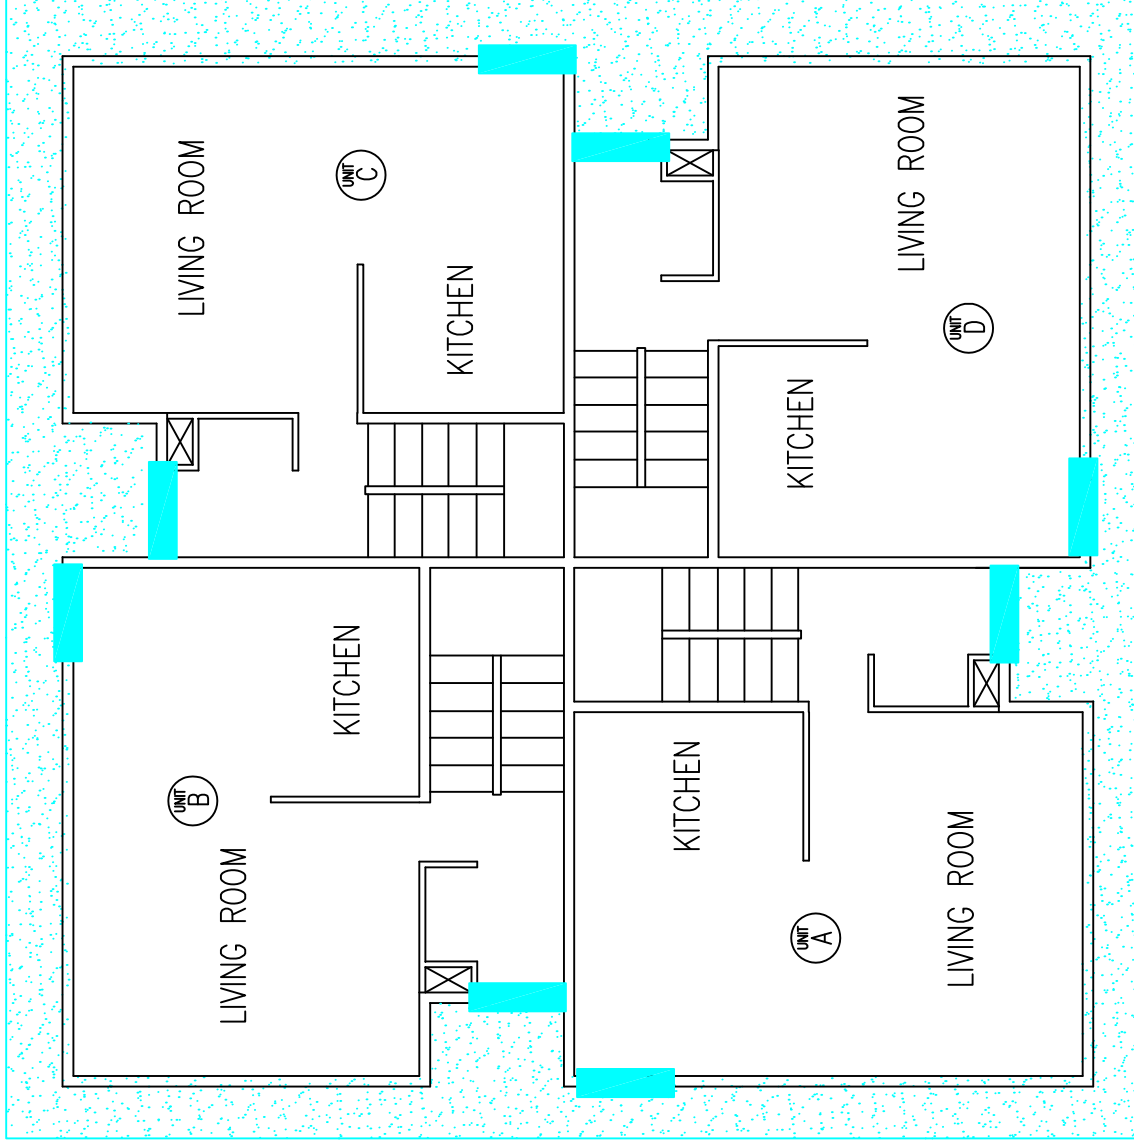
DIAGRAM 187-10 SAMPLING LOCATIONS

- LEAD-BASED PAINT ON EXTERIOR DOOR JAMBS
- TAN/WHITE LEAD-BASED PAINT ON LOWER SOFFIT

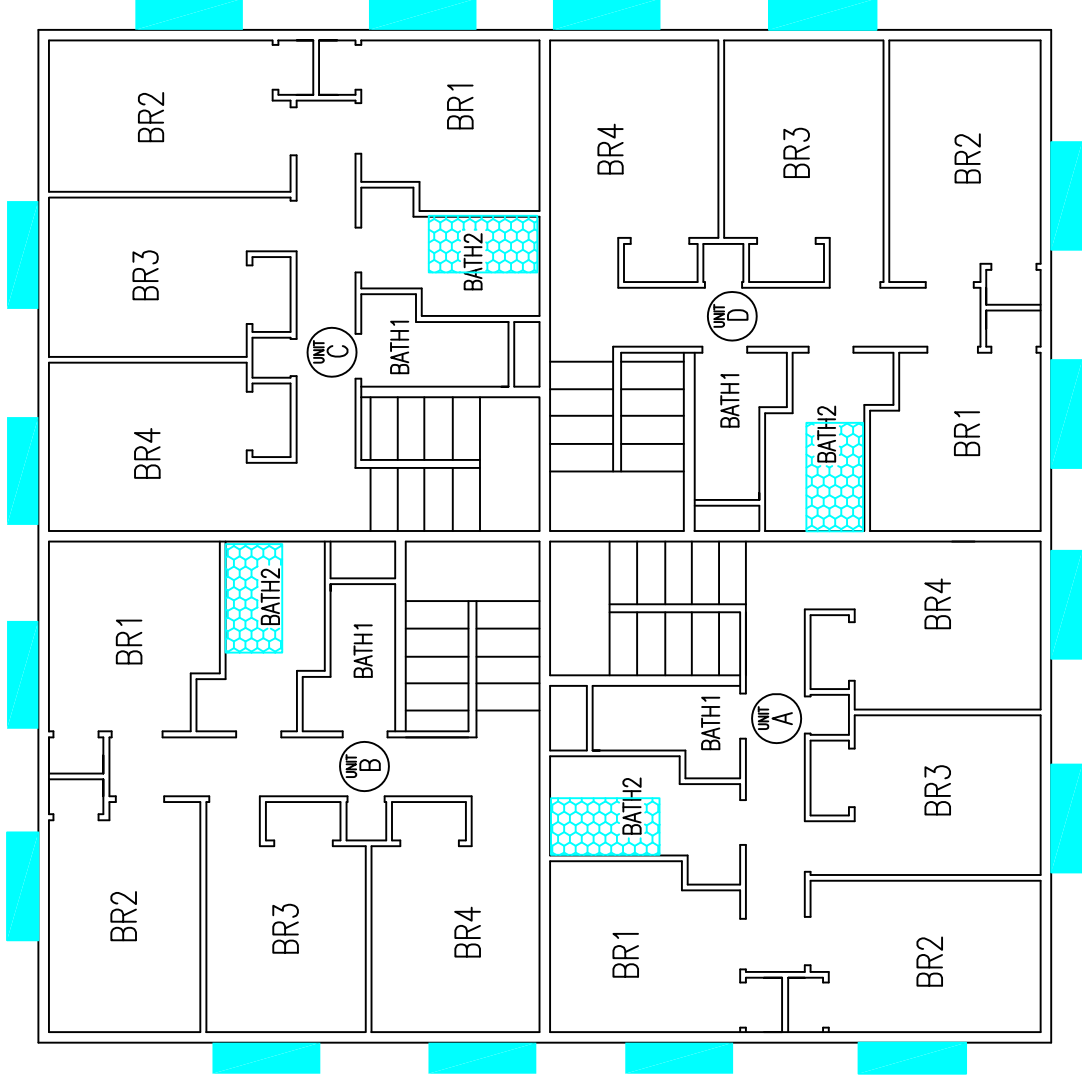
DIAGRAM 187-11

-LEAD-BASED PAINT ON EXTERIOR VERTICAL WINDOW CASING (2"X6" BOARDS)

-LEAD-BASED PAINT ON TUB

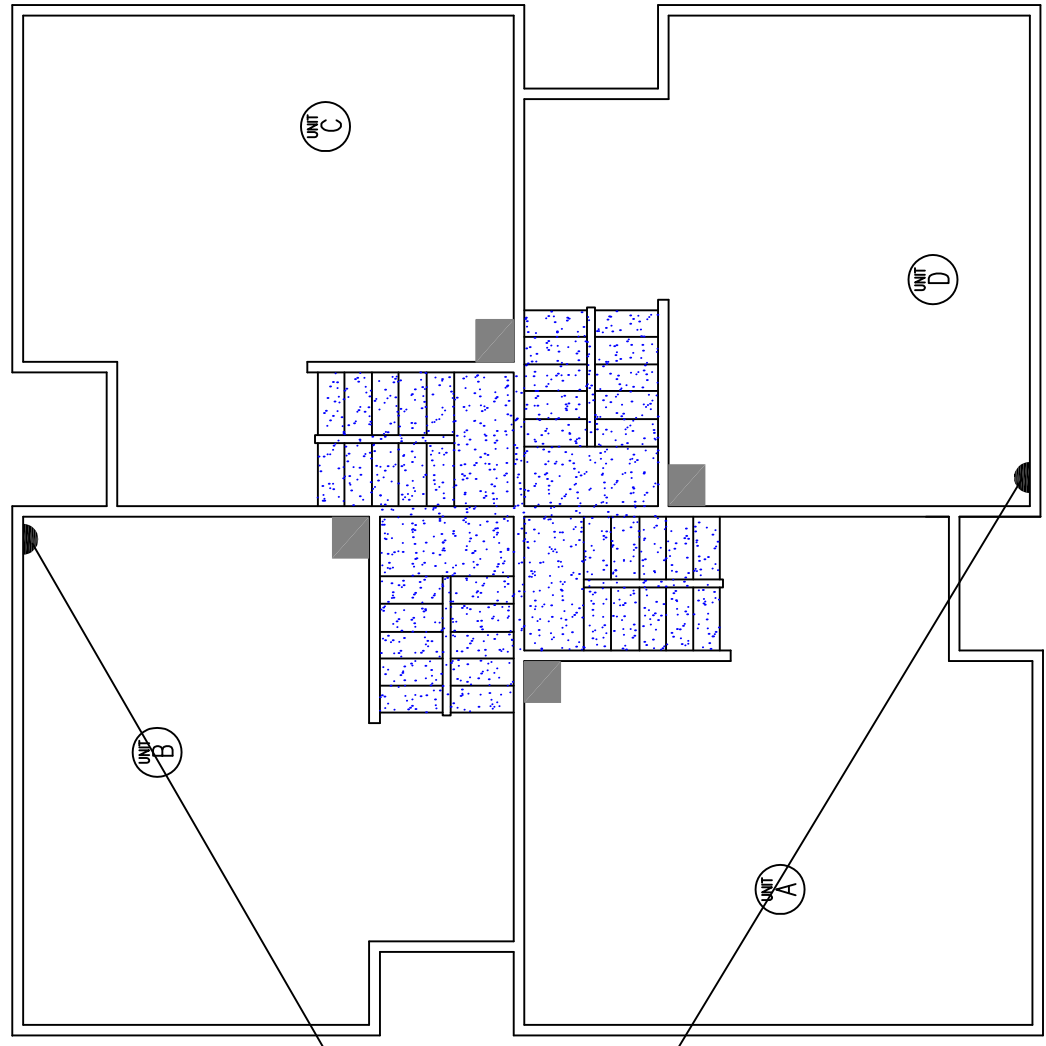
DIAGRAM 191-6
ASBESTOS TAPING COMPOUND LOCATIONS

ELECTRICAL CONDUIT
PENETRATION PUTTY

-ASBESTOS FLUE PACKING/MORTAR
AT LOWER (OLD) HOLE

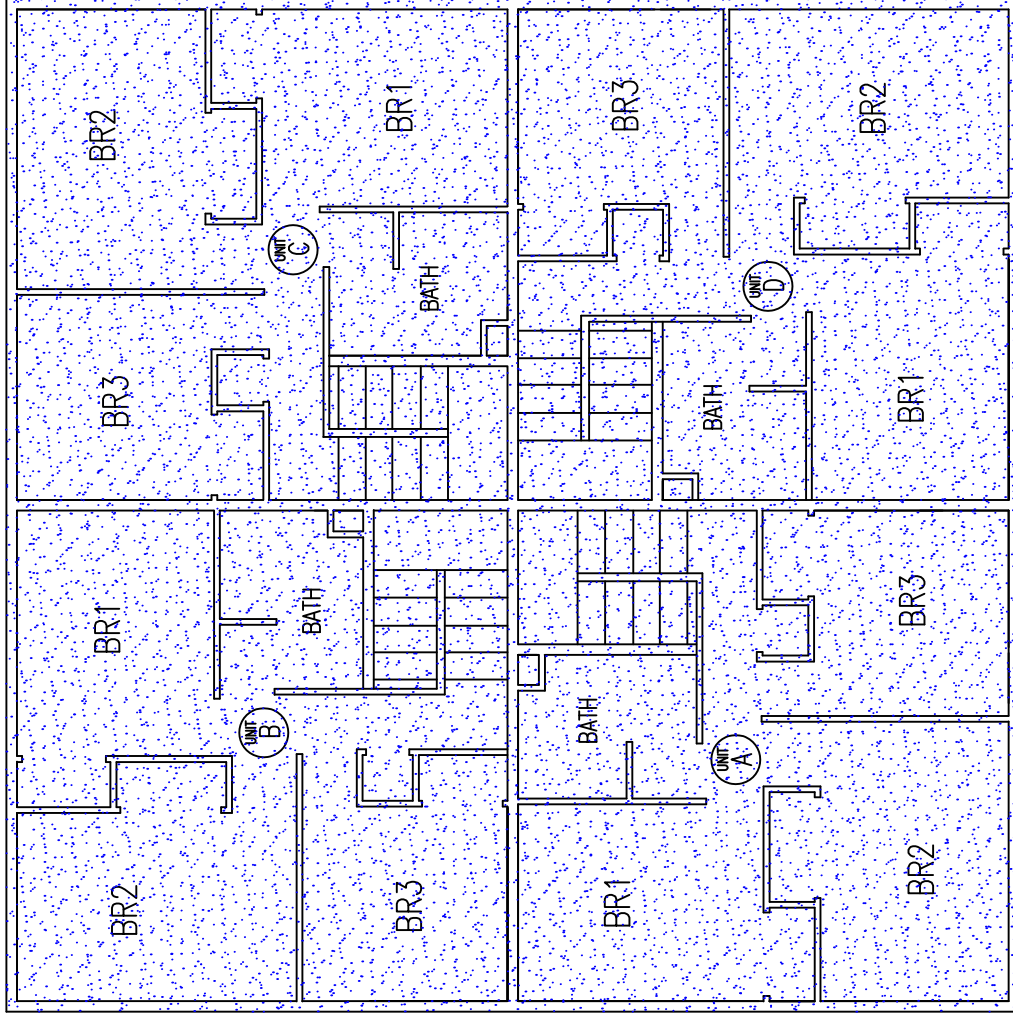
DIAGRAM 191-8
ASBESTOS TAPING COMPOUND LOCATIONS

-ASBESTOS TAPING/JOINT COMPOUND

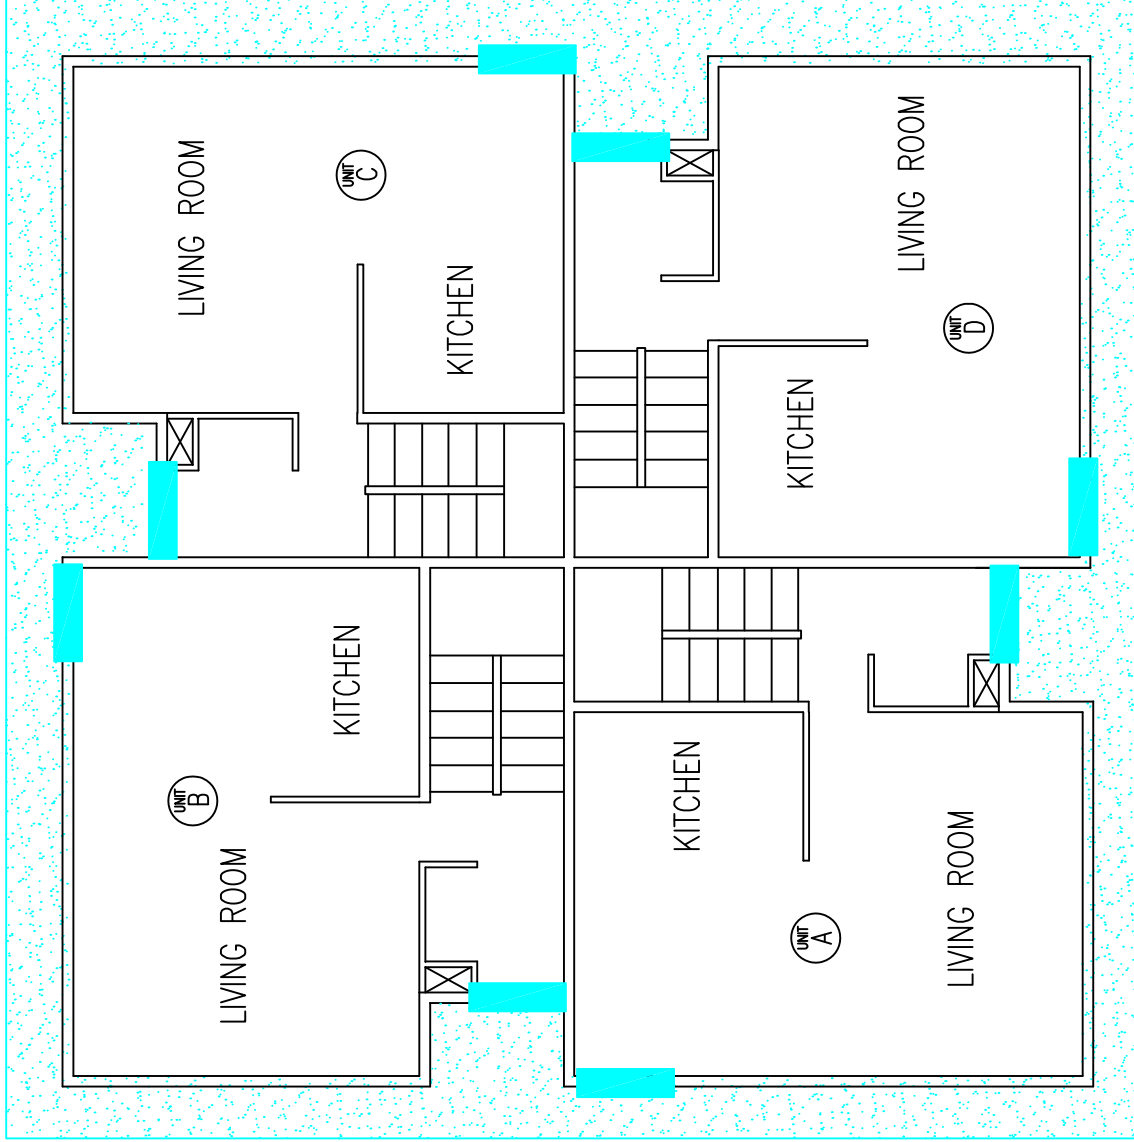
DIAGRAM 191-10 SAMPLING LOCATIONS

- LEAD-BASED PAINT ON EXTERIOR DOOR JAMBS
 - TAN/WHITE LEAD-BASED PAINT ON LOWER SOFFIT

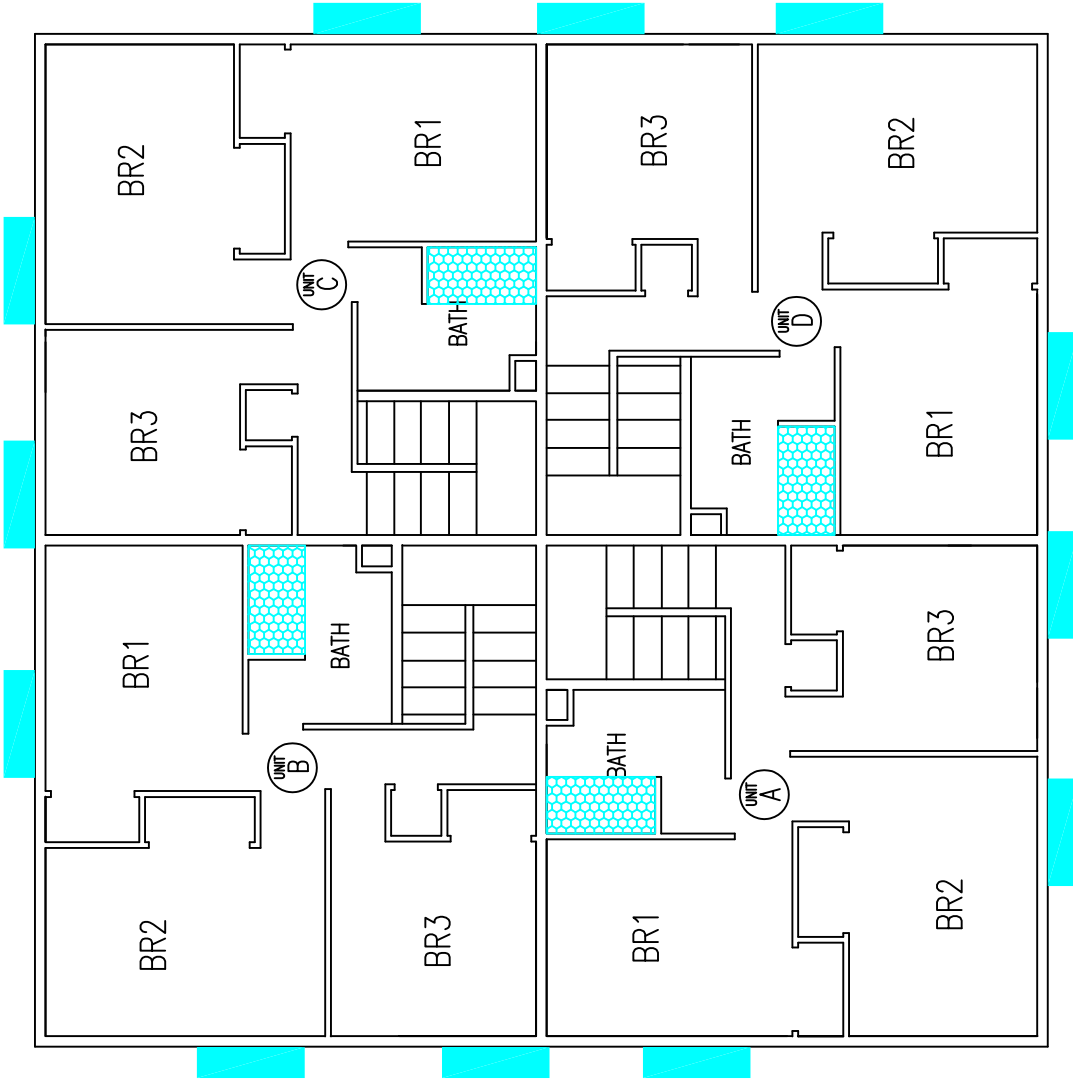
DIAGRAM 191-11
LEAD-BASED PAINT LOCATIONS

- LEAD-BASED PAINT ON EXTERIOR VERTICAL WINDOW CASING (2"X6" BOARDS)
- LEAD-BASED PAINT ON TUB
