**FINAL REPORT
ASBESTOS SAMPLING &
LEAD PAINT TESTING**

**DUNEDIN TERRACE
RESIDENTIAL UNITS 175-218**

**ST. PAUL PUBLIC HOUSING AGENCY
261 EAST UNIVERSITY AVENUE
ST. PAUL, MN 55101**

January 8, 2015

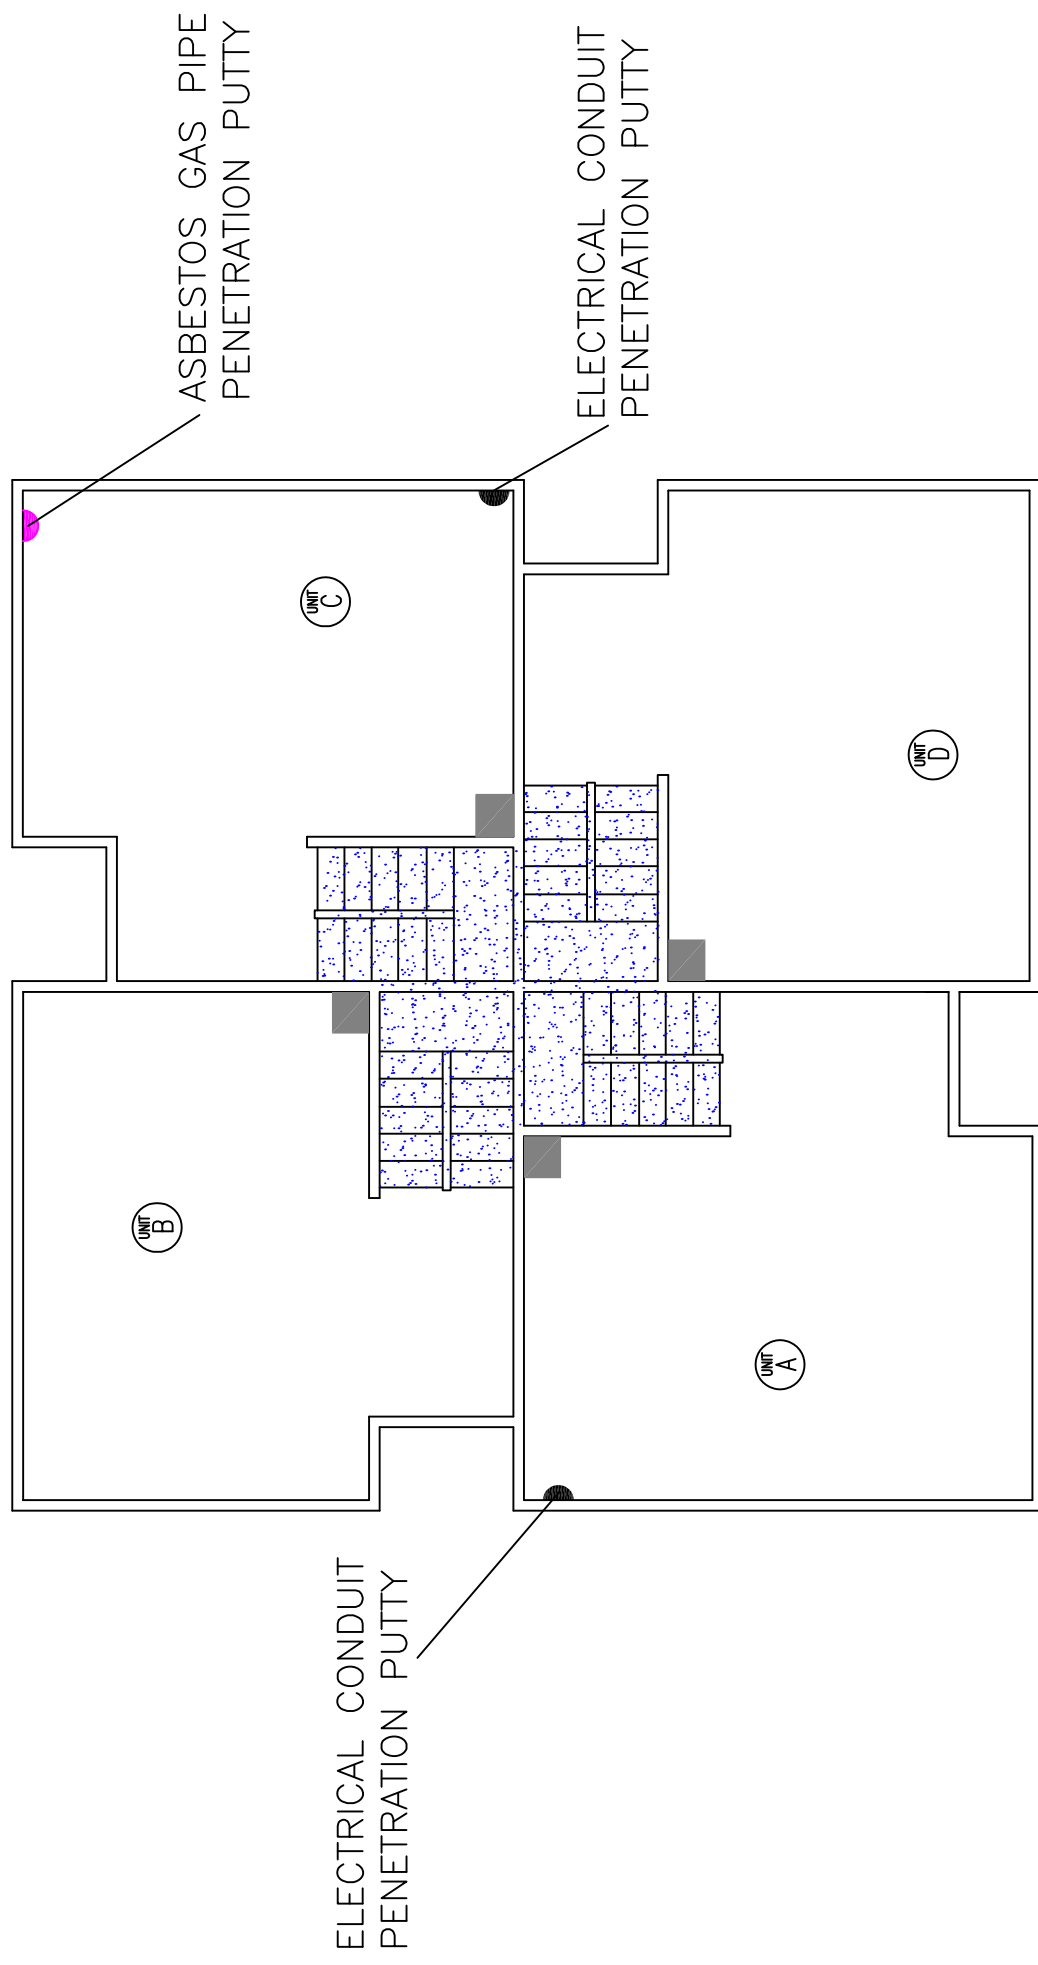
DIAGRAM 195-5
MISCELLANEOUS ASBESTOS MATERIAL LOCATIONS

-ASBESTOS FLUE PACKING/MORTAR AT LOWER (OLD) HOLE

-ASBESTOS TAPING/JOINT COMPOUND

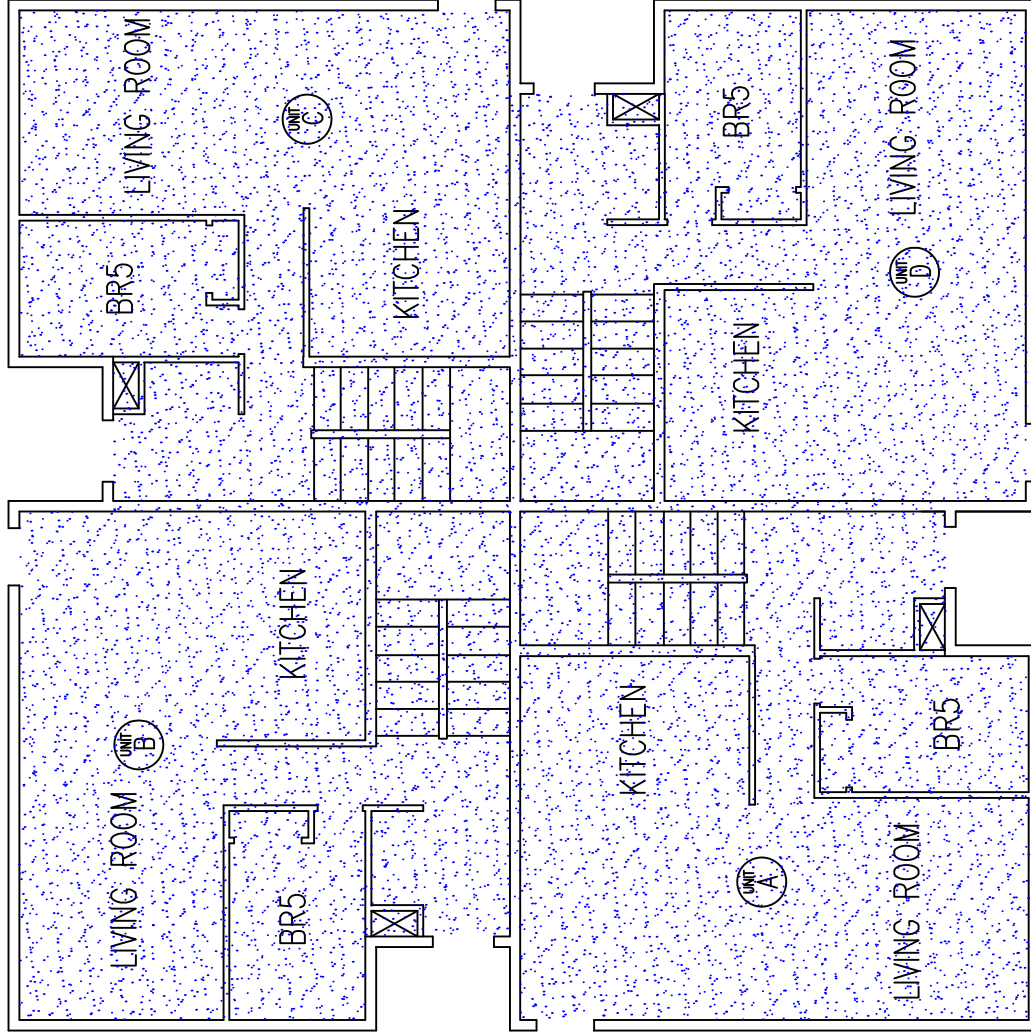
DIAGRAM 195-6
TAPING COMPOUND LOCATIONS

-ASBESTOS TAPING/JOINT COMPOUND

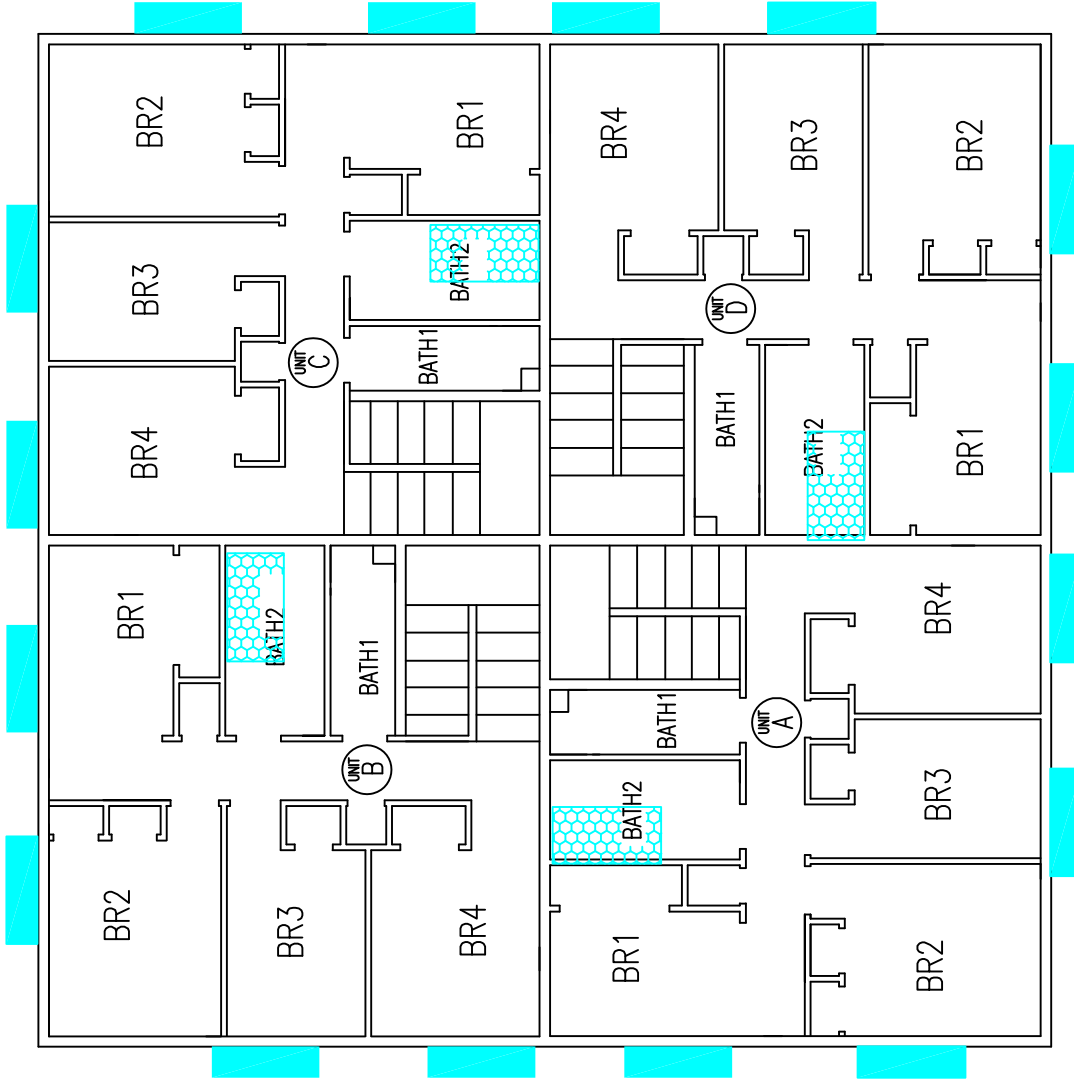
DIAGRAM 195-10
LEAD-BASED PAINT LOCATIONS

- LEAD-BASED PAINT ON EXTERIOR VERTICAL WINDOW CASING (2" X 6" BOARDS)
- LEAD-BASED PAINT ON TUB

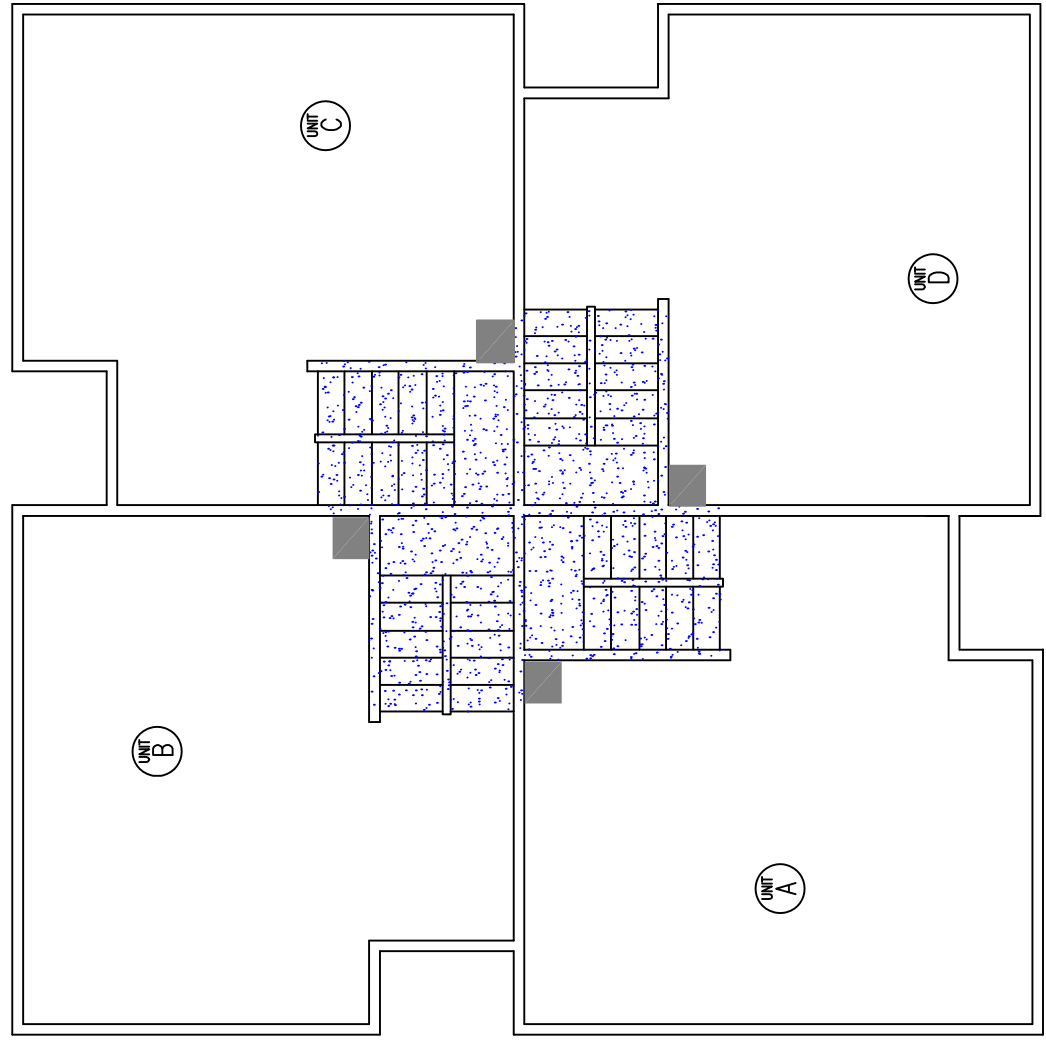
DIAGRAM 199-6
ASBESTOS TAPING COMPOUND LOCATIONS

-ASBESTOS FLUE PACKING/MORTAR AT LOWER (OLD) HOLE

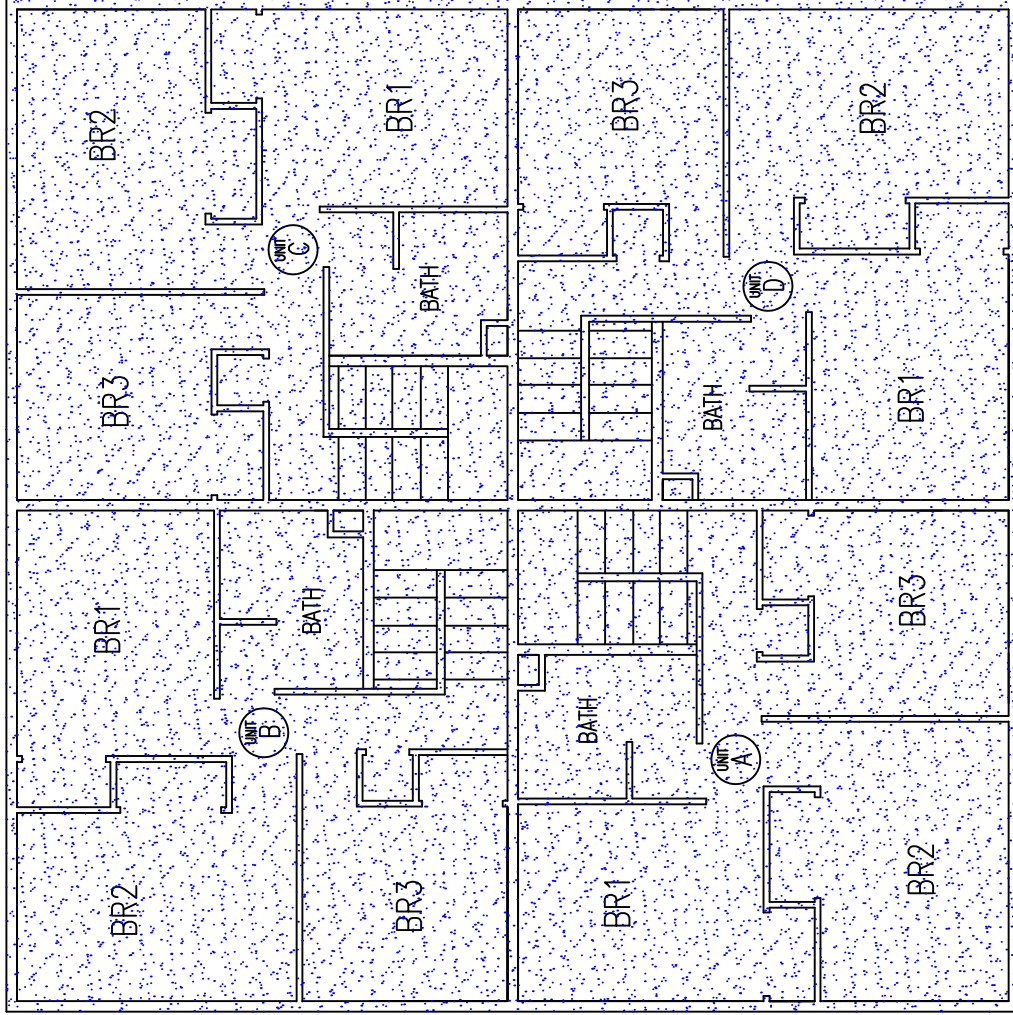
DIAGRAM 199-8
ASBESTOS TAPING COMPOUND LOCATIONS

-ASBESTOS TAPING/JOINT COMPOUND

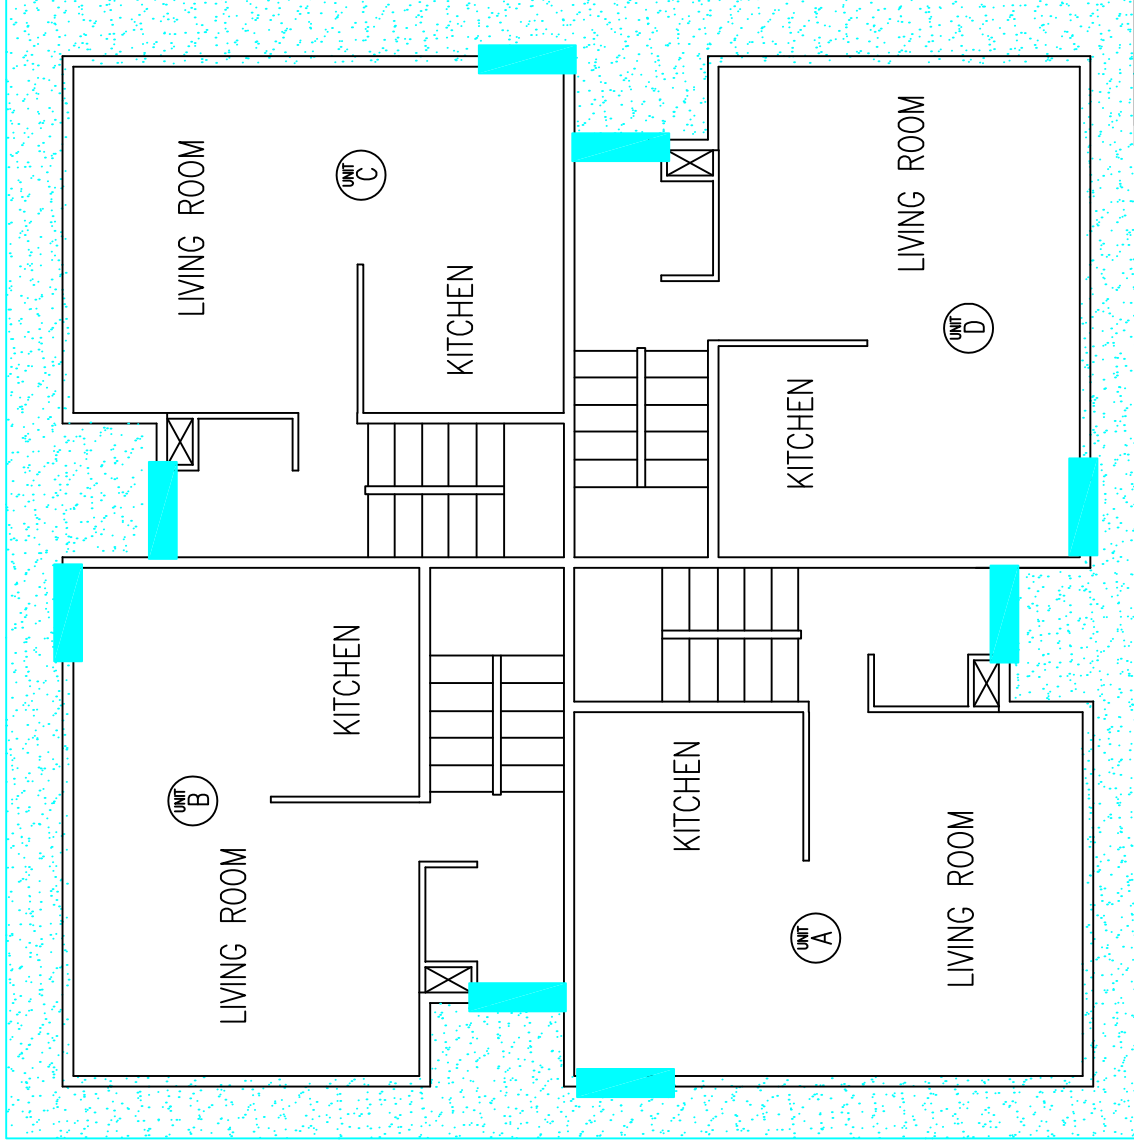
DIAGRAM 199-10 SAMPLING LOCATIONS

— LEAD-BASED PAINT ON EXTERIOR
DOOR JAMBS

— TAN/WHITE LEAD-BASED PAINT ON
LOWER SOFFIT

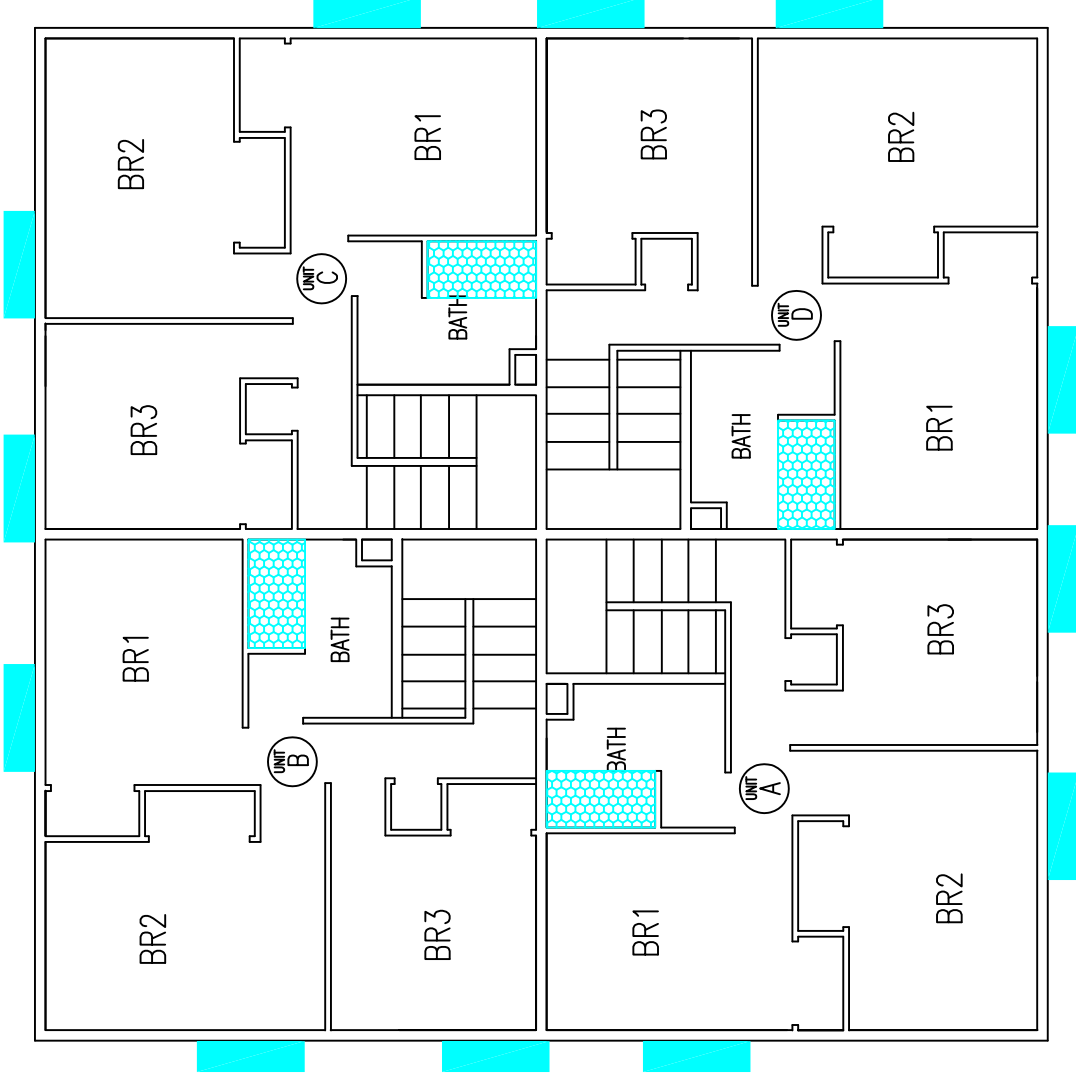
DIAGRAM 199-11
LEAD-BASED PAINT LOCATIONS

- LEAD-BASED PAINT ON EXTERIOR VERTICAL WINDOW CASING (2"X6" BOARDS)
- LEAD-BASED PAINT ON TUB

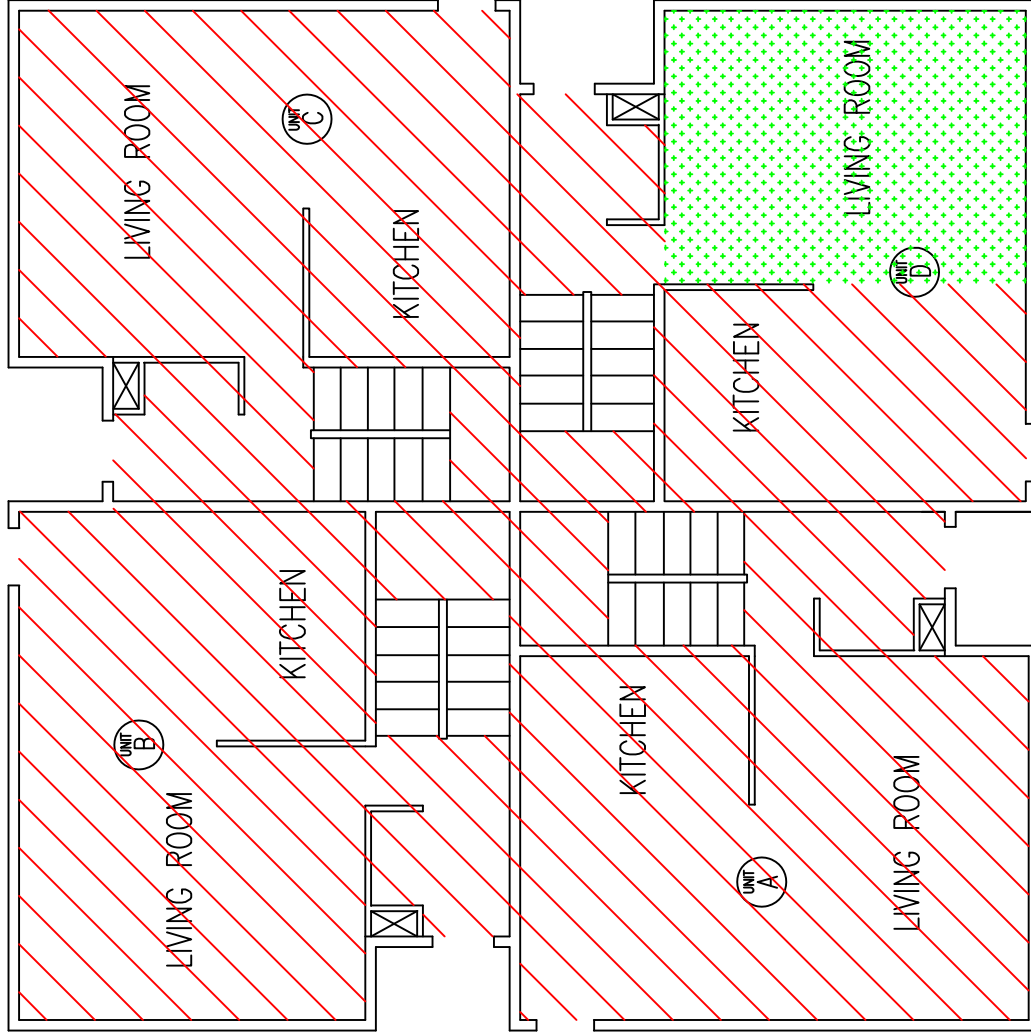
DIAGRAM 204-3 ASBESTOS FLOORING LOCATIONS

-ASBESTOS FLOOR TILE MASTIC UNDER
 NON-ASBESTOS FLOOR TILES UNDER
 NON-ASBESTOS SHEET FLOORING
 -ASBESTOS FLOOR TILE MASTIC UNDER
 NON-ASBESTOS FLOOR TILES

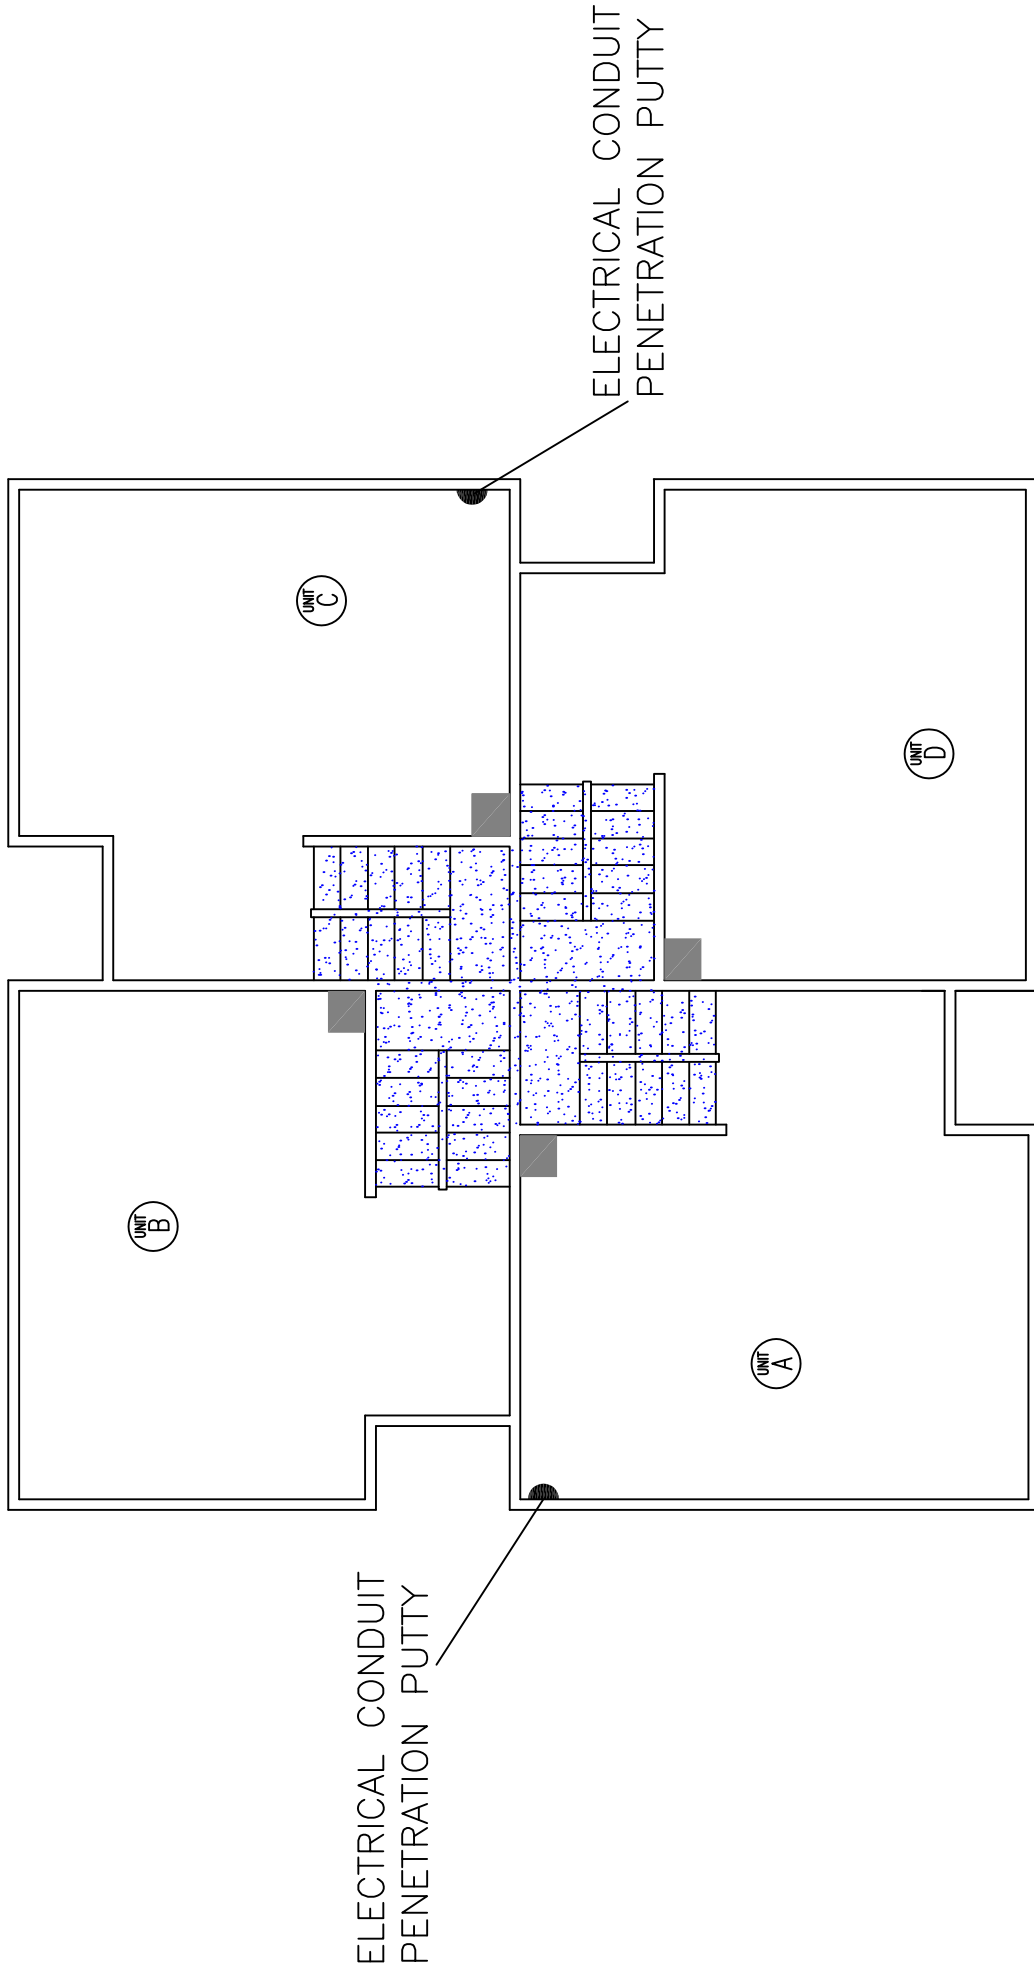
DIAGRAM 204-5 TAPING COMPOUND LOCATIONS

- ASBESTOS FLUE PACKING/MORTAR AT LOWER (OLD) HOLE
- ASBESTOS TAPING/JOINT COMPOUND

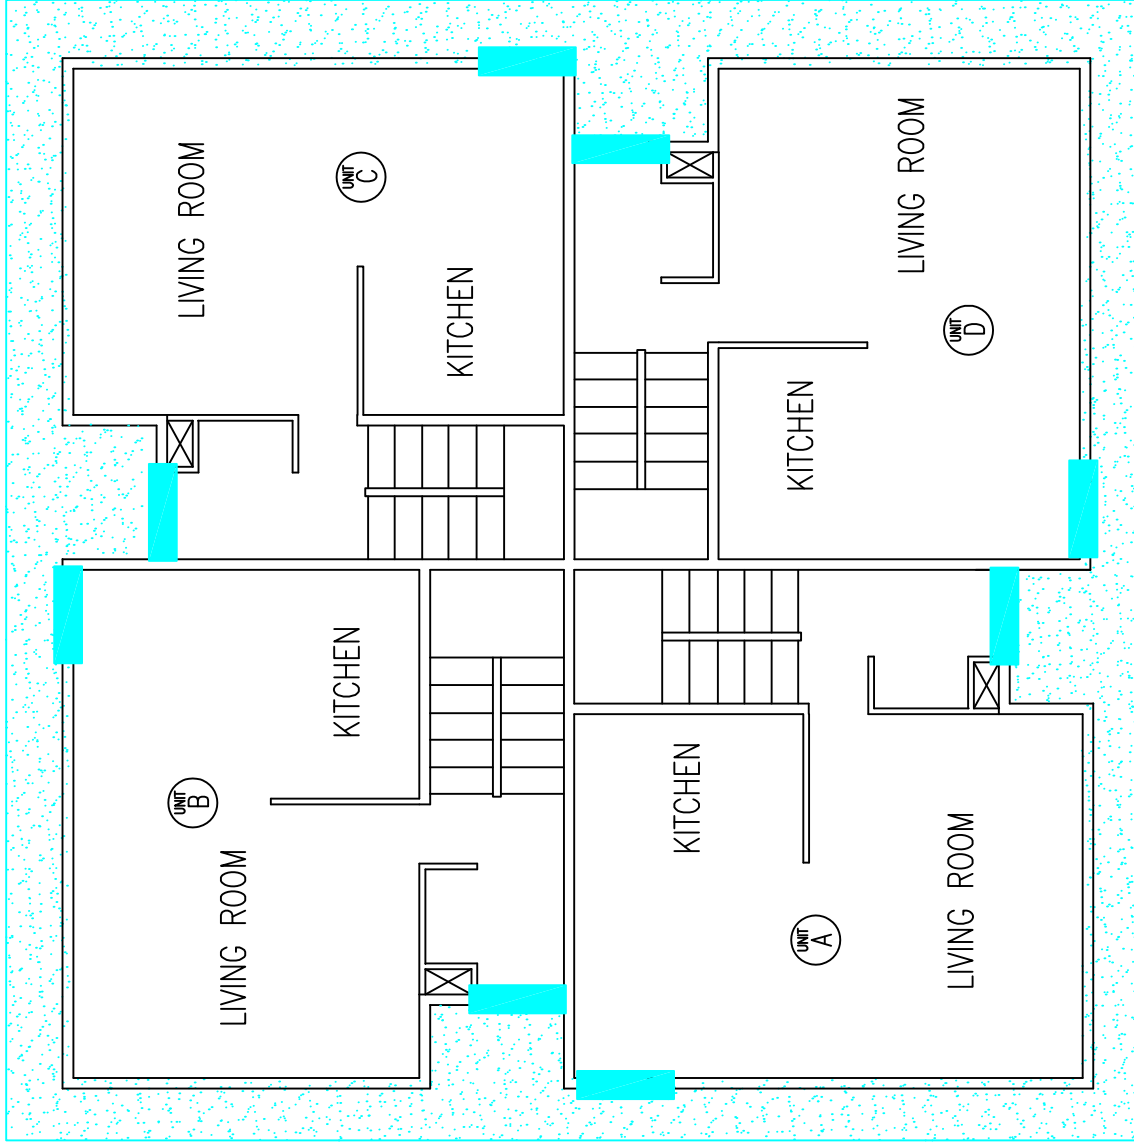
DIAGRAM 204-9
 SAMPLING LOCATIONS

- LEAD-BASED PAINT ON EXTERIOR DOOR JAMBS
- TAN/WHITE LEAD-BASED PAINT ON LOWER SOFFIT

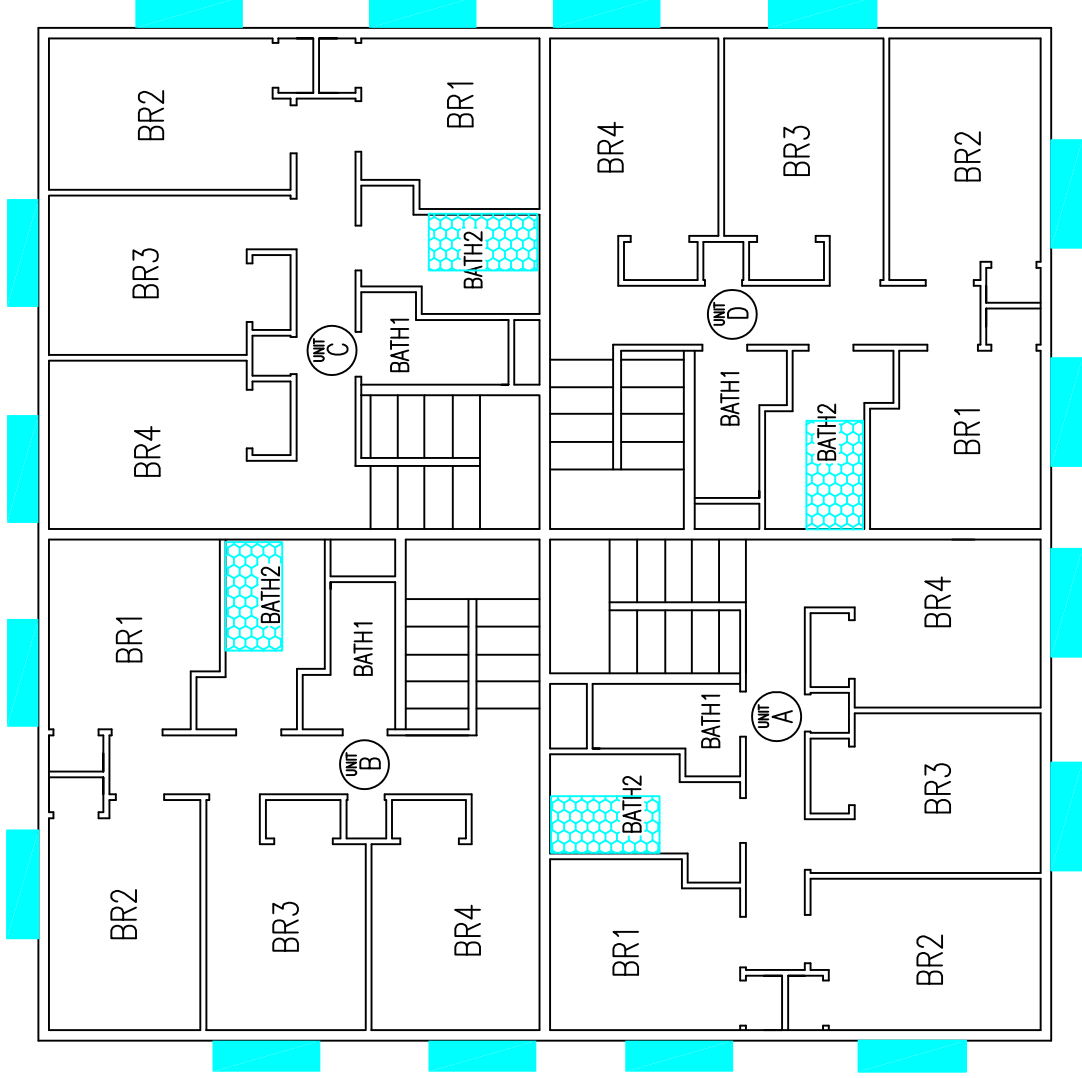
DIAGRAM 204-10

- LEAD-BASED PAINT ON EXTERIOR VERTICAL WINDOW CASING (2" X 6" BOARDS)
- LEAD-BASED PAINT ON TUB

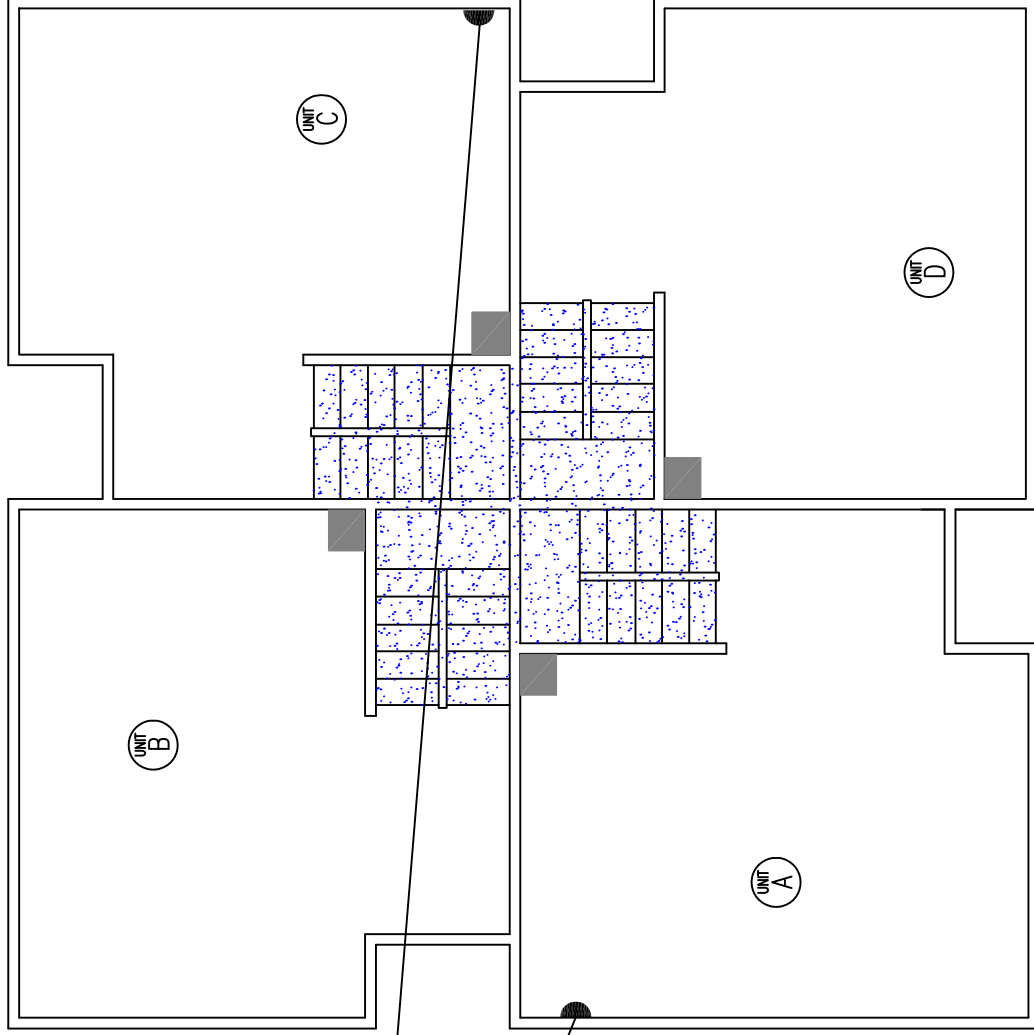
DIAGRAM 218-5 TAPING COMPOUND LOCATIONS

ELECTRICAL CONDUIT
PENETRATION PUTTY

- ASBESTOS FLUE PACKING/MORTAR AT LOWER (OLD) HOLE
- ASBESTOS TAPING/JOINT COMPOUND

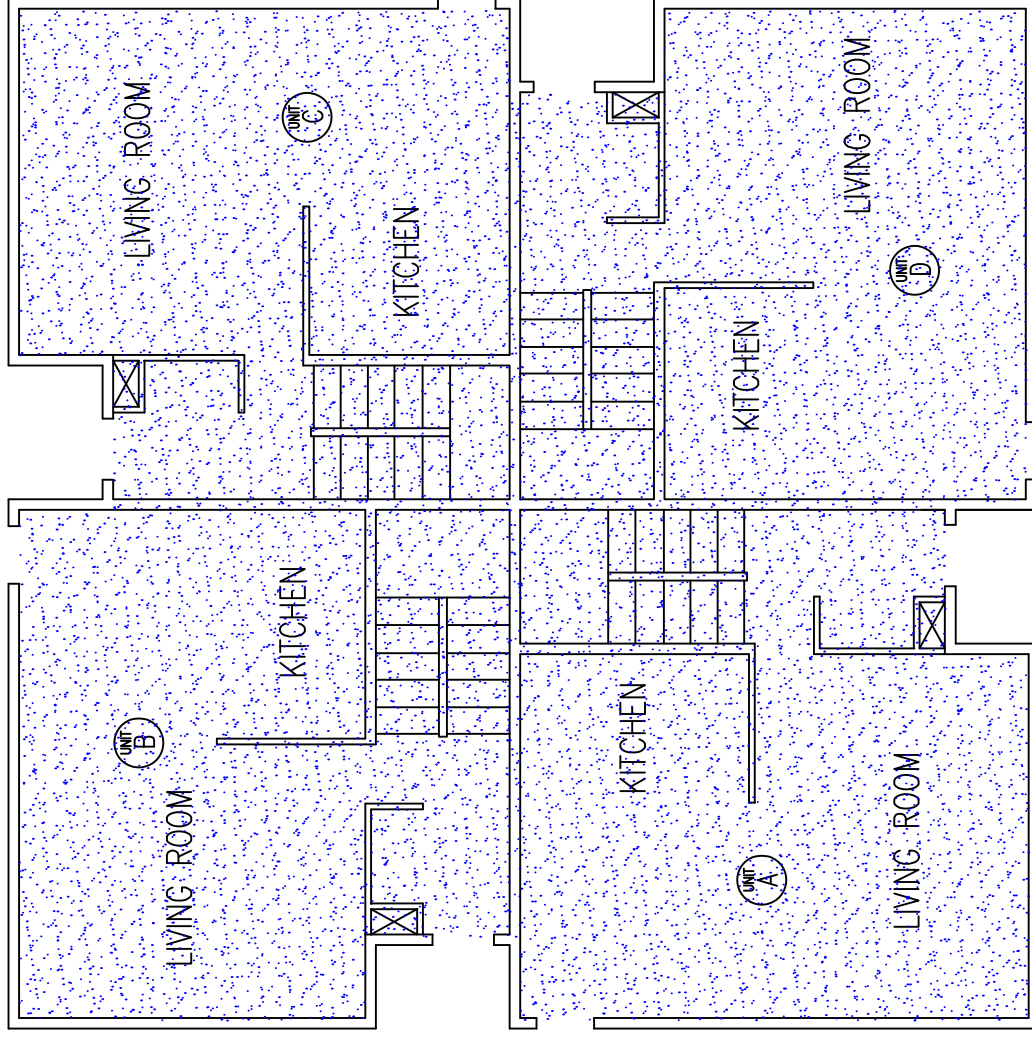
DIAGRAM 218-6
TAPING COMPOUND LOCATIONS

-ASBESTOS TAPING/JOINT COMPOUND

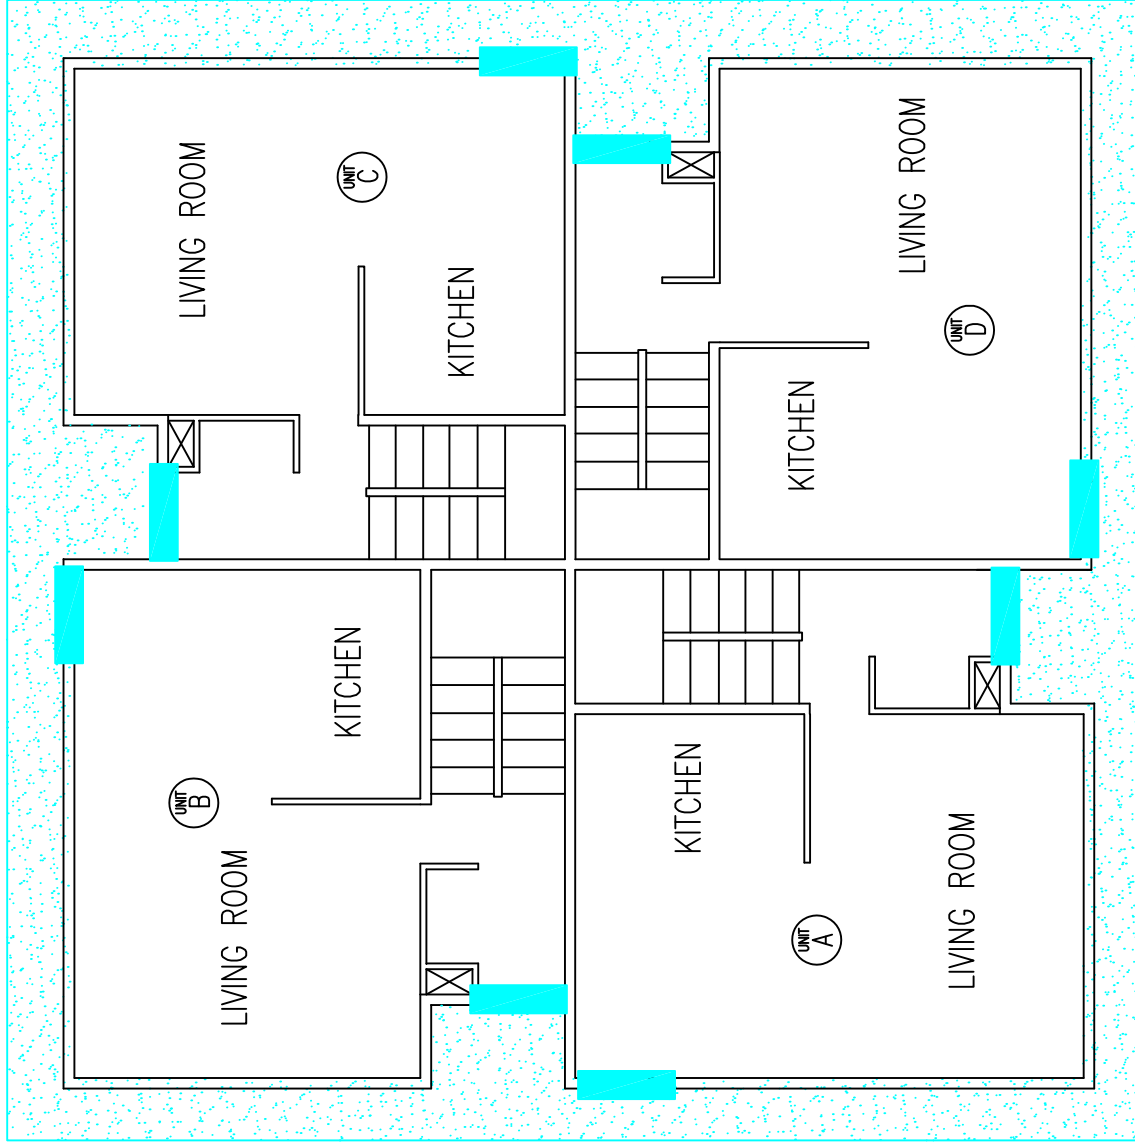
DIAGRAM 218-9 SAMPLING LOCATIONS

- LEAD-BASED PAINT ON EXTERIOR DOOR JAMBS
- TAN/WHITE LEAD-BASED PAINT ON LOWER SOFFIT

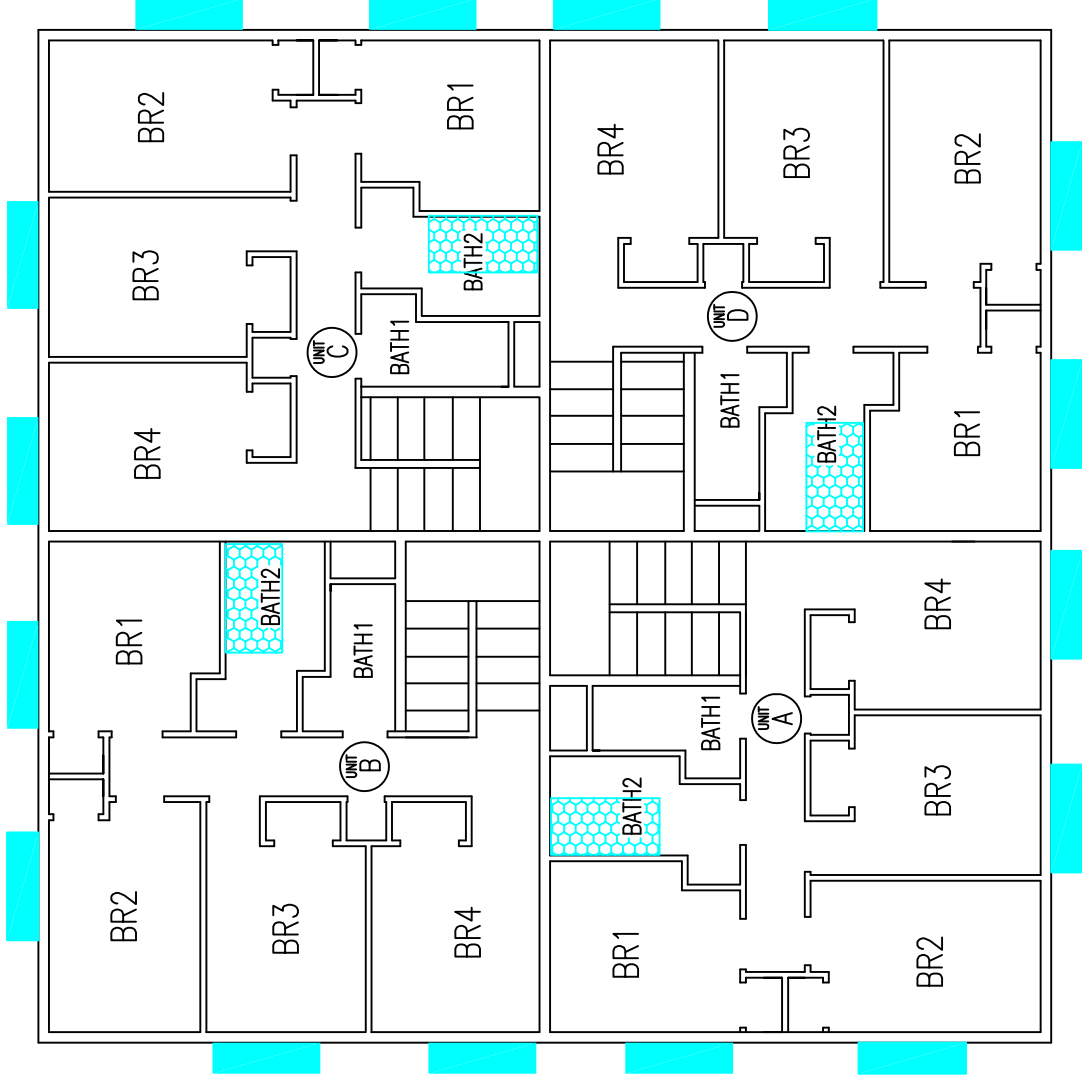
DIAGRAM 218-10

- LEAD-BASED PAINT ON EXTERIOR VERTICAL WINDOW CASING (2" X 6" BOARDS)
- LEAD-BASED PAINT ON TUB
