**FINAL REPORT
ASBESTOS SAMPLING &
LEAD PAINT TESTING**

**DUNEDIN TERRACE
RESIDENTIAL UNITS 175-218**

**ST. PAUL PUBLIC HOUSING AGENCY
261 EAST UNIVERSITY AVENUE
ST. PAUL, MN 55101**

January 8, 2015

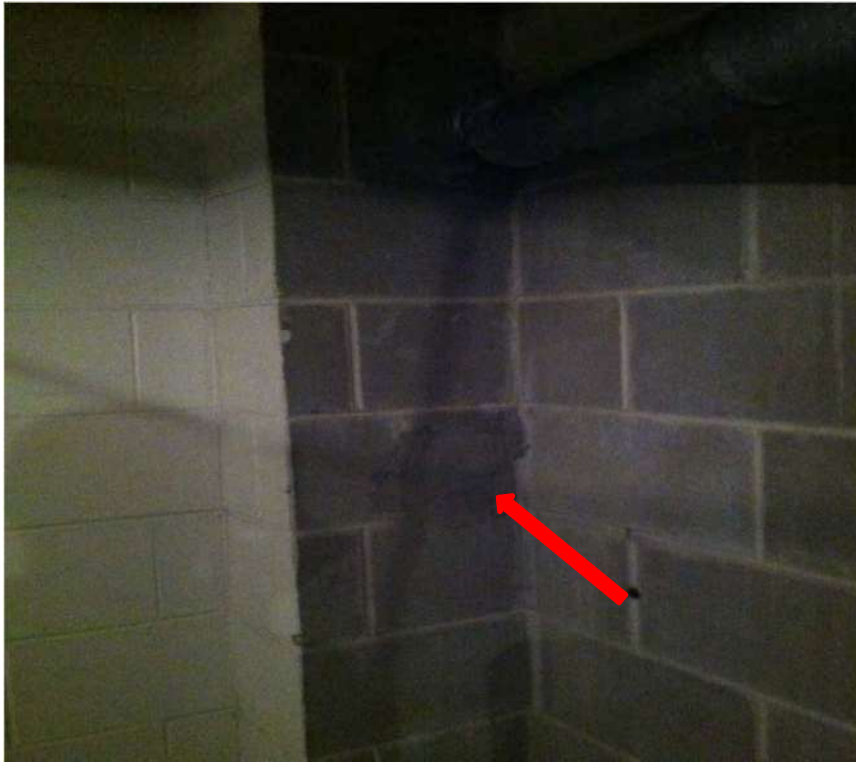
Photo 1 – ACM Packing on Old Chimney Flue Opening

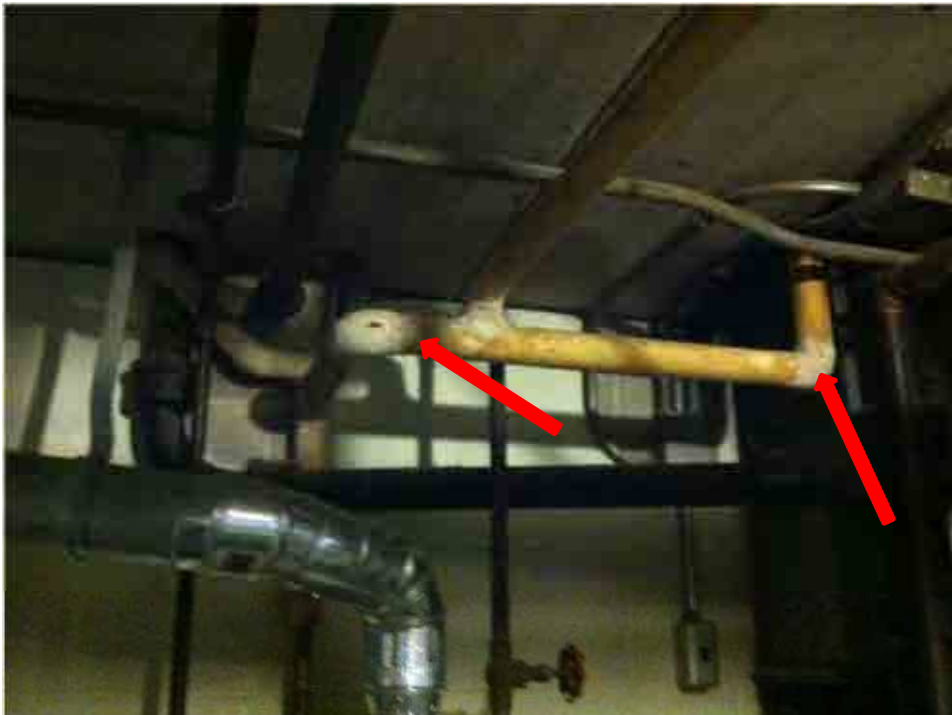
Photo 2 – ACM Pipe Fitting Insulation

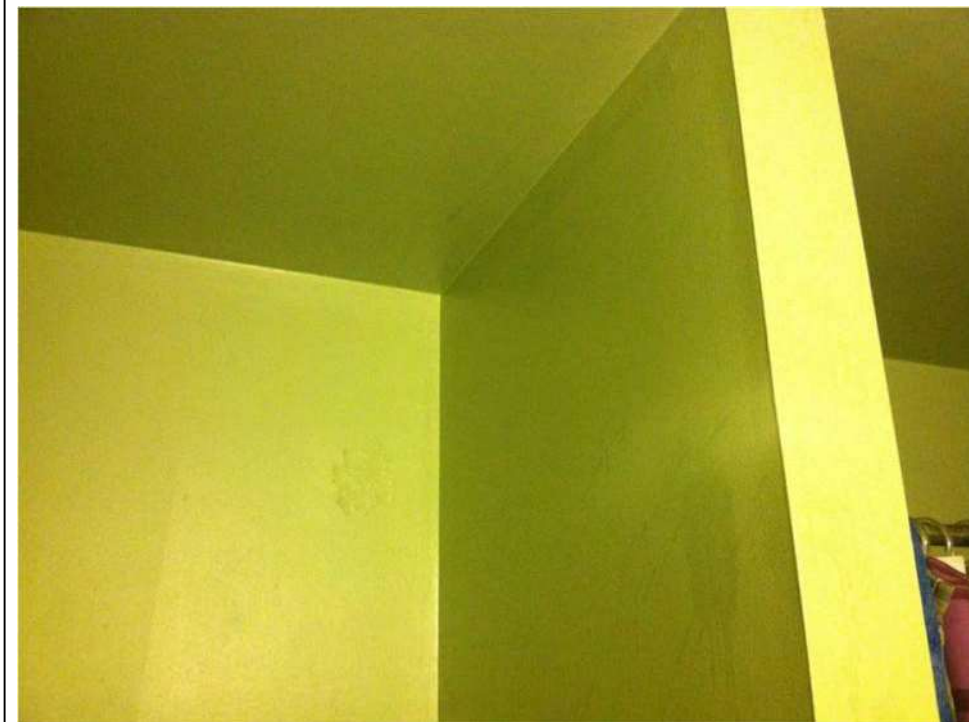
Photo 4 – ACM Joint Compound on Non-ACM Drywall

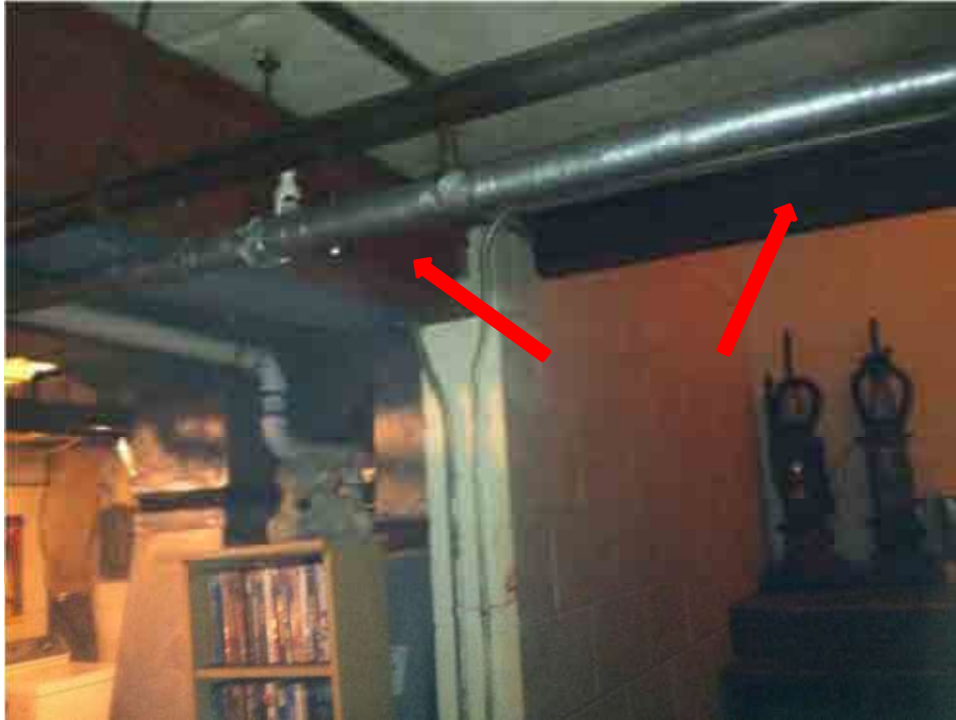
Photo 5 – Lead-Based Paint on Metal I-Beam & Angle Iron in Basements

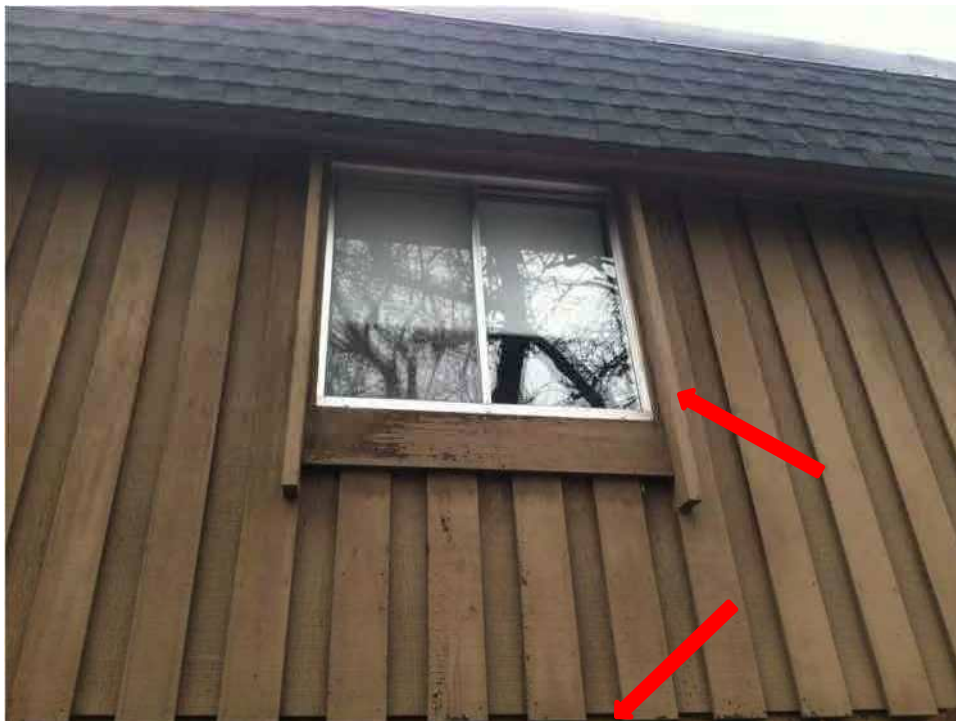
Photo 6 – Lead-Based Paint on Exterior Window Casing Boards & Lower Soffits
